**Department of Public Works Facility
Garage, Facility Analysis and Space
Needs Assessment**

**Harvard, Massachusetts
November 3, 2021**

Proj: Harvard Department of Public Works Facility
Re: Facility Analysis and Space Needs Assessment
CBI Job No. CB211030

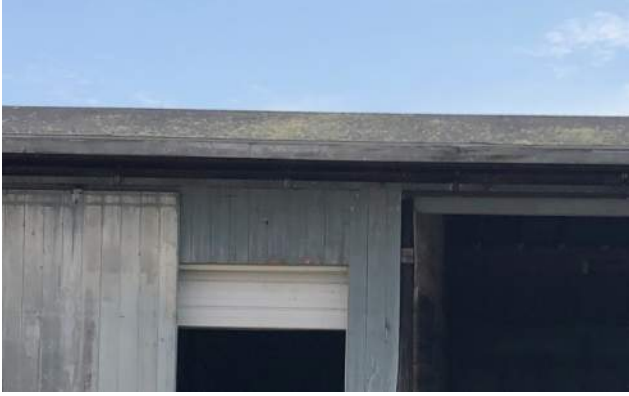
In general, the condition of the roof is poor. This description is largely due to the deficiencies found during CBI's review. CBI observed weathered and deteriorated single tab asphalt shingles. Organic growth has accumulated on the surface of the roof shingles (Refer to Photographs 2).

Weathered and deteriorated single tab asphalt shingles
3.

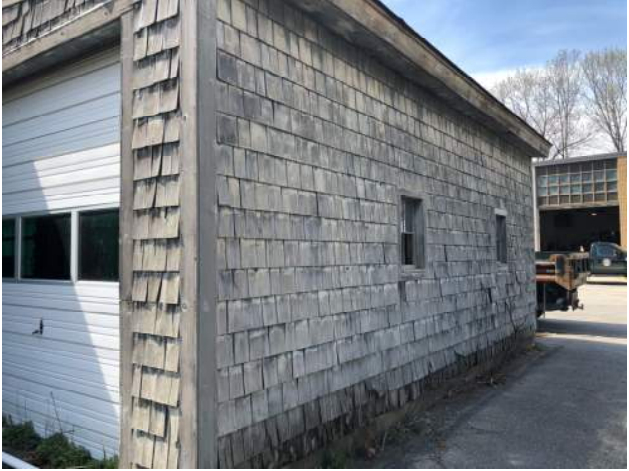
The condition of the exterior wood shingle walls are in poor condition. There are sections where shingles are missing, deteriorated shingles due to water damage and warped/coupling of shingles. (Refer to Photographs 3 and 4). There are gaps between the vertical wall wood siding allowing water infiltration to reach stored materials. (Refer to Photograph 5).

Deteriorated wood shingles. Image 1 of 2.

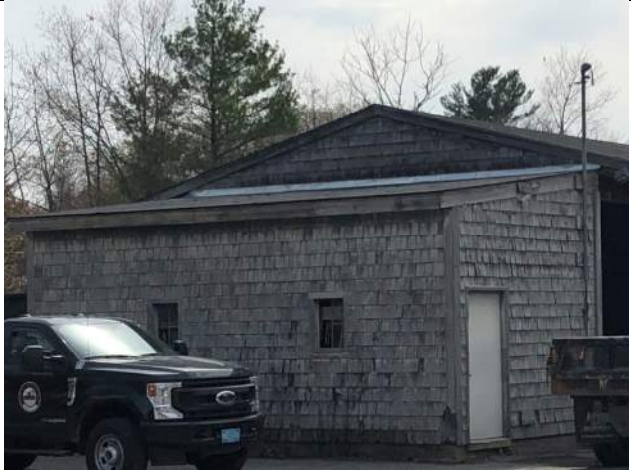
4.

Deteriorated wood shingles. Image 2 of 2.
5.

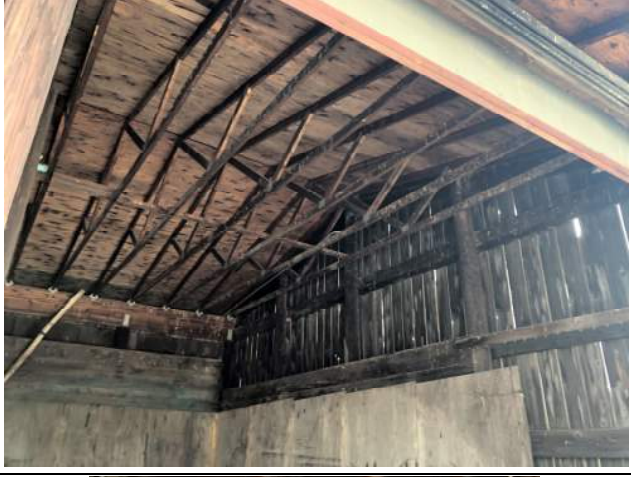
There are gaps between the vertical wall wood siding allowing water infiltration to reach stored materials.
6.

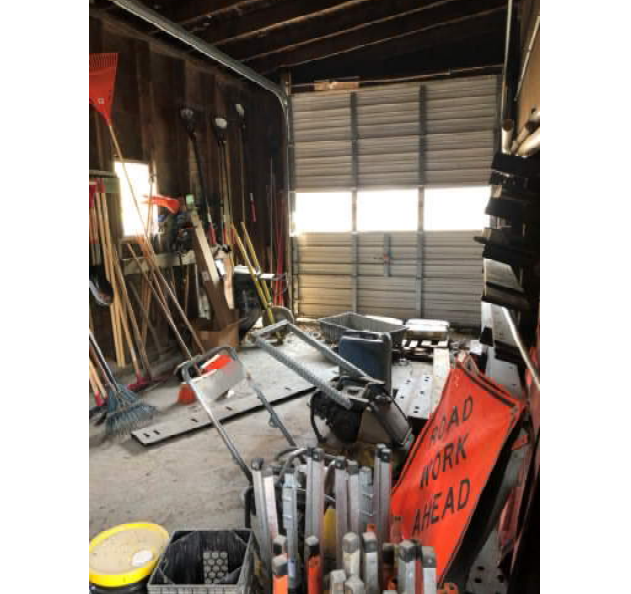
In general, the condition of the windows and doors are poor. The fixed wood windows are missing glazing panels, and also are missing sealant around the framed openings. The sliding bay wood door shows signs of delamination due to weather exposure. The two (2) existing manually operated overhead metal doors bay doors are single ply metal and appear low grade to withstand operation of a material storage garage. (Refer to Photographs 6 and 7).

The manually operated overhead metal door bay doors are single ply metal.

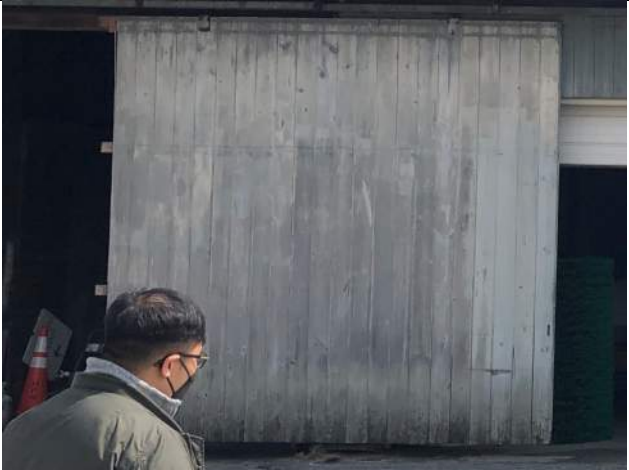
7.

General view of the Pole Barn / Storage Garages sliding wood door
----	---	---

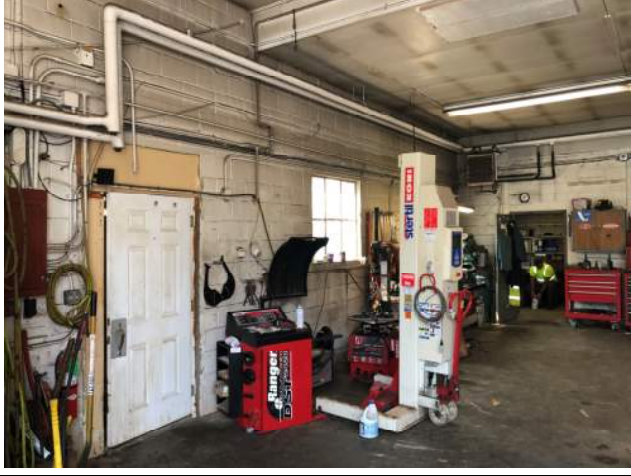
The low ceiling in the mechanic garage restricts servicing larger vehicles on the auto floor lifts.
3.

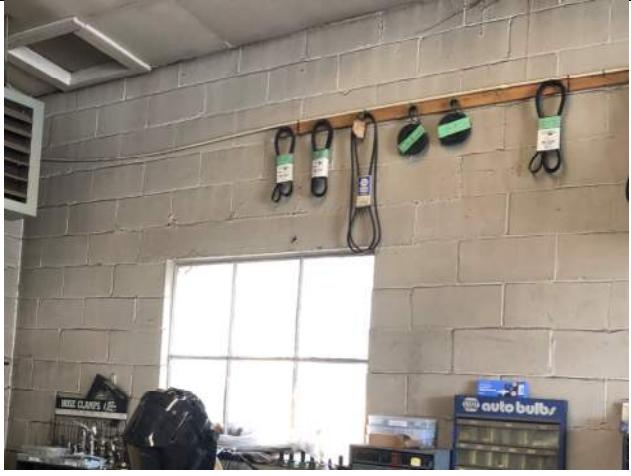
4.

The condition of the single uninsulated wythe concrete masonry block walls appears to be in fair condition. There are areas of individual block interior surfaces not aligned with adjacent blocks thus creating uneven mortar joints which eventually will allow water into the building. (refer to Photograph 4).

<p>There are areas of individual concrete masonry block interior surfaces not aligned with adjacent blocks.</p>
5.

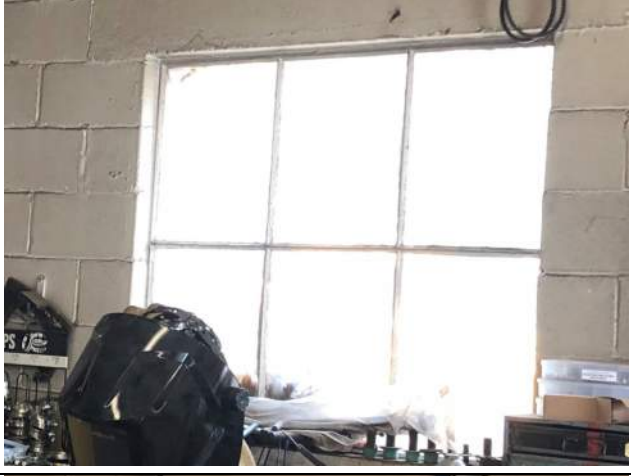
In general, the condition of the windows are poor. The windows are drafty fixed wood frame single plane glazed windows with deteriorated putty around the wood muntins. (refer to Photograph 5). The exterior metal door appears to be in fair condition. The one (1) bay overhead metal door is manually operated and appears to be in good condition (refer to Photograph 6).

<p>View of one of the wood frame single plane glazed windows with deteriorated putty around the wood muntins.</p>
6.

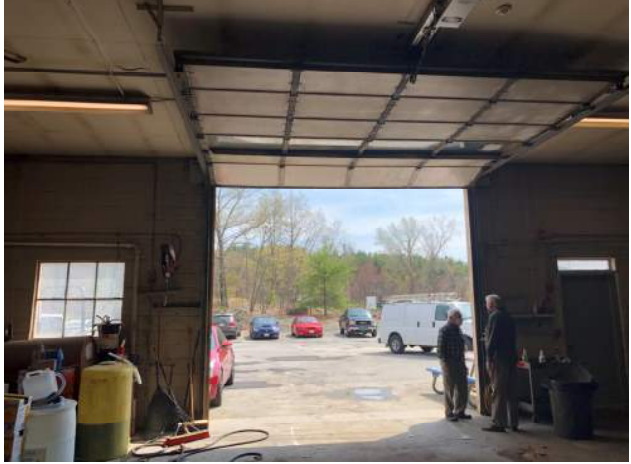
<p>The one (1) bay overhead metal door is manually operated and appears to be in good condition.</p>

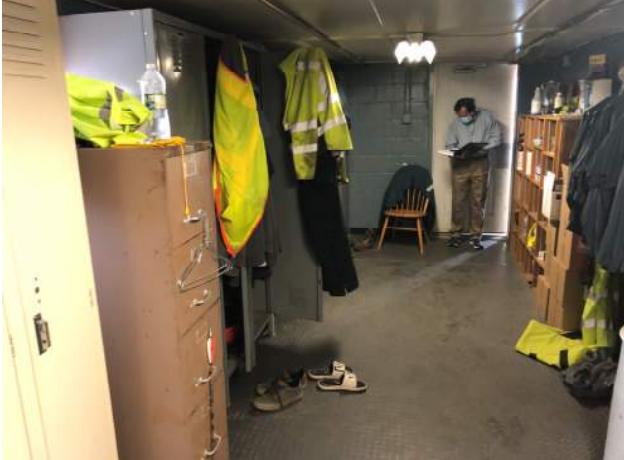
In general, the office storage capacity is inadequate with the office storage overflow located in the corridor. The use of the corridor for locker room changing area and for storage creates an egress safety hazardous condition. There is also the use of lack of privacy for the location of the lockers in the corridor.

<p>The use of the corridor for locker room changing area and for storage creates an egress safety hazardous condition. There is also the lack of privacy for staff uniform changing.</p>

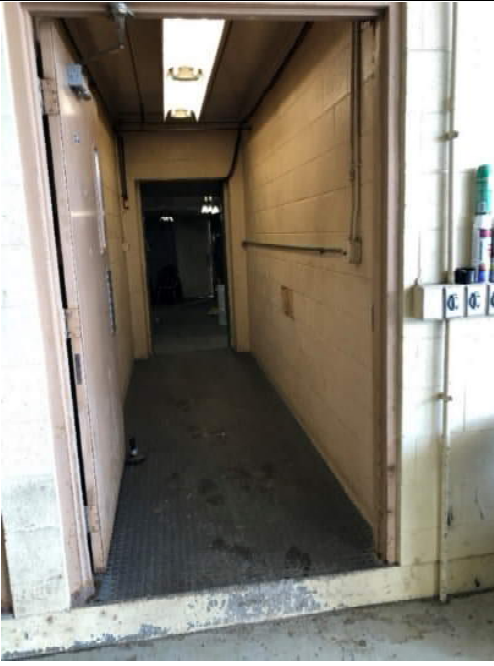
4.

<p>The floor elevation in the corridor leading from the “connector” building to the large vehicle storage garage contains a step and does not meet accessibility requirements.</p>
5.

The existing raised corridor floor from the existing six Bay Vehicle Storage Garage to the DPW office is proposed to be lowered to comply with accessibility requirements, which will include removal and replacement of the slab on grade. Underpinning will be required of the flanking existing masonry bearing wall foundations of the corridor. Unsuitable soils would be removed and replaced with structural fill. A new concrete slab-on-grade is proposed.

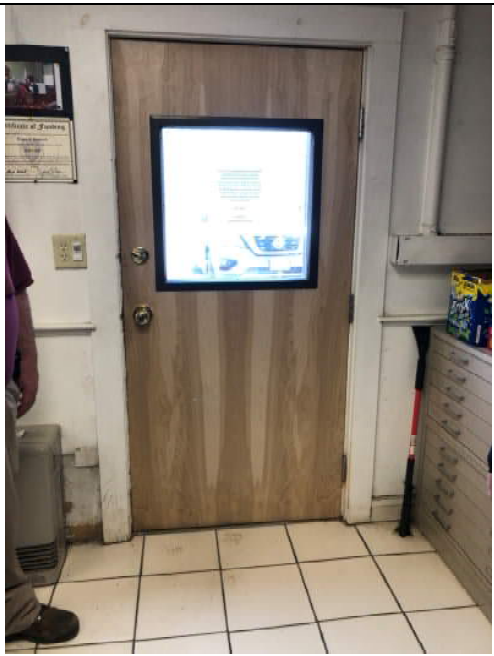
In general, the condition of the window is poor. The sliding wood window is drafty with a single glazed plane. The exterior office entrance wood door is a residential wood grade door not suitable for weather exposure. (refer to Photograph 6).

<p>View of the office exterior main entrance residential wood grade door.</p>

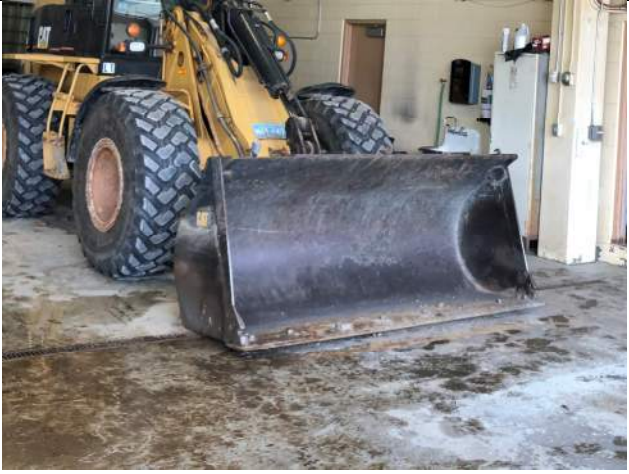
3.

There are large, deteriorated sections of the traffic epoxy floor finish and pitted concrete floor in the garage caused by water and de-icing salts. (refer to Photograph 3). The male multi-user toilet room 12"x12" ceramic tiles are in fair condition with deteriorated tile joints. The radial rubber floor in the break room and the unisex bathroom appears to be in good condition.

<p>Deteriorated sections of the traffic epoxy floor finish and pitted concrete floor in the garage caused by water and de-icing salts.</p>
4.	 	<p>The unisex toilet interior metal door and frame and exhibit signs of rust.</p>

The six (6) bay vehicle storage garage building appears to be in good condition and the DPW is not looking to expand its footprint. However, accessibility upgrades are required in the unisex toilet room to comply with ADA code regulations, including reconfiguration of toilet partition, new plumbing fixture and accessories and reconfiguration of the shower stall. Also, the existing ramp and rails is required be reconfigured to comply with slope and handrails requirements. The male multi-user toilet room plumbing fixtures and finishes appear to be fair, are outdated and should be replaced. A new ramp with handrails and a new door approach clearance is required for accessibility from the garage to the break room. The entire traffic epoxy floor finish in the garage should be removed, the pitted concrete areas should be patched and a new heavy duty traffic epoxy finish applied to the entire floor.

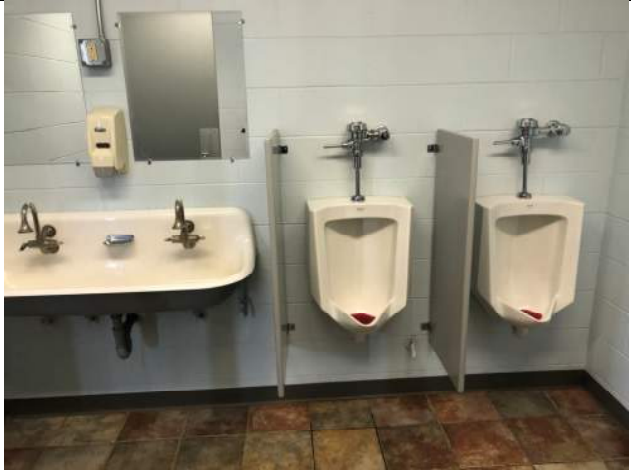
5.

<p>The male multi-user toilet room plumbing fixtures appear to be fair but are outdated. The fixtures and heights are not handicap accessible.</p>
6.

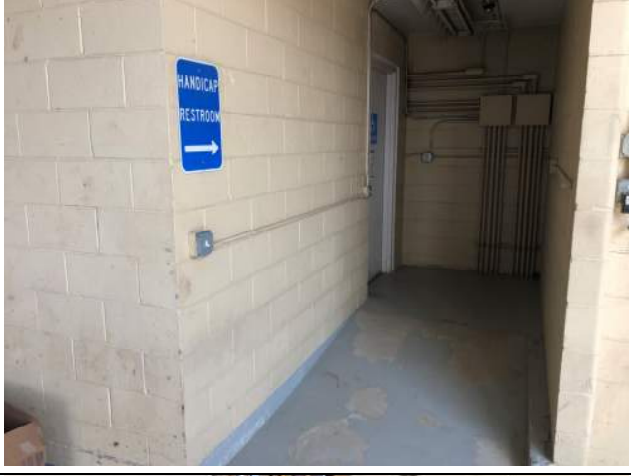
<p>The existing ramp leading to the unisex bathroom exceeds the slope requirements of 1/12 pitch. It also lack handrails on both sides.</p>
7.

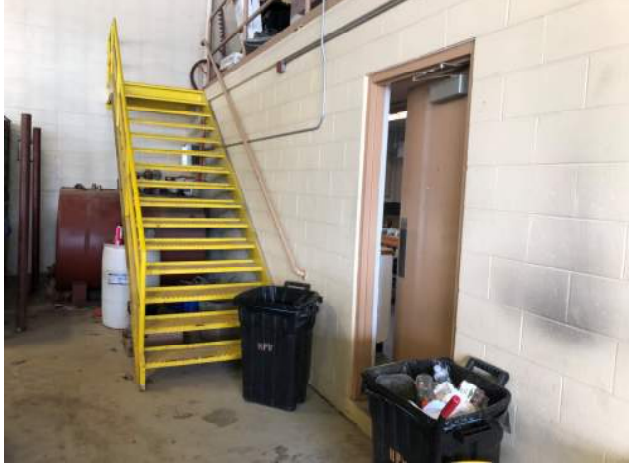
room to the garage floor does not meet accessibility requirements, (refer to Photograph 7). The unisex toilet room does not meet ADA accessibility requirements including maneuver clearances within the toilet partition and the shower stall approach and there is no shower seating as required by the accessibility code. (refer to Photograph 8 & 9).

<p>The 7-1/2" raised floor elevation from the break room to the garage floor does not meet accessibility requirements and it also creates a tripping hazard.</p>

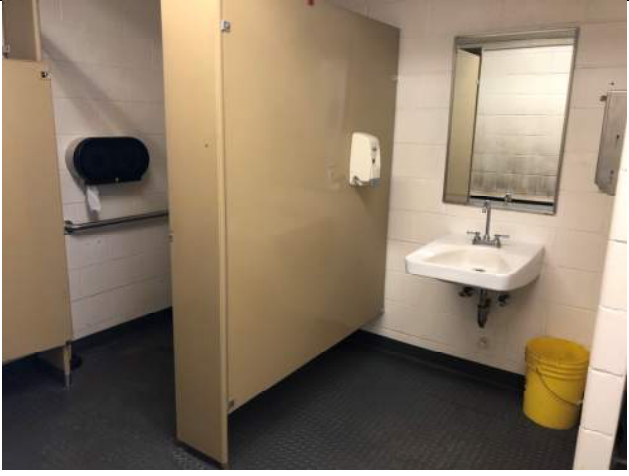
8.

<p>The unisex toilet room does not meet ADA accessibility requirements for the maneuver clearances within the toilet partition</p>
9.

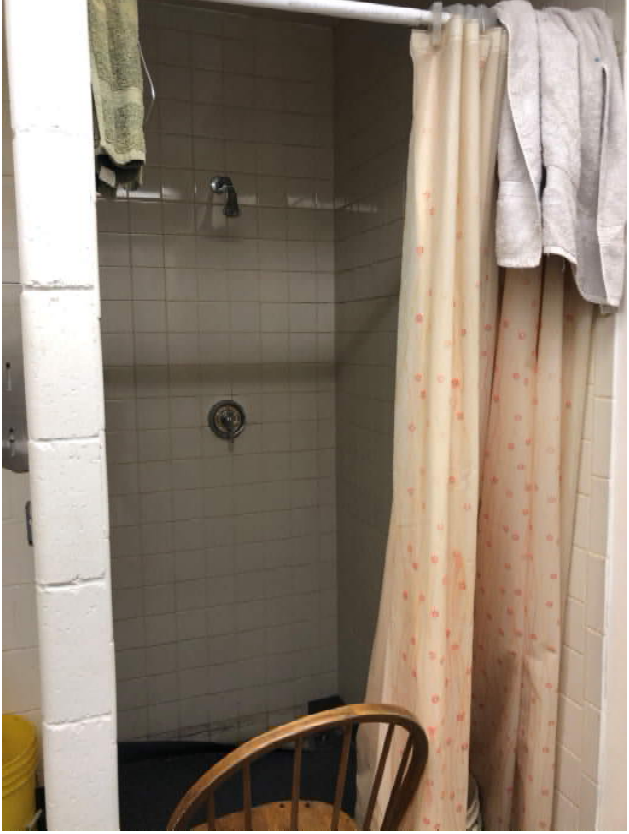
<p>The unisex toilet room does not meet ADA accessibility for the shower stall approach and lack of seating</p>

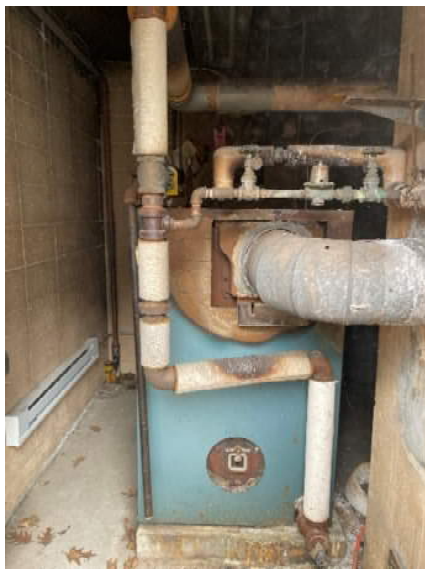
Abandoned Boiler

5. New Pole Barn: No heating, ventilating or air conditioning is planned.
6. Existing boiler, piping, etc. that has been abandoned in place in the mechanical room will be removed in its entirety.

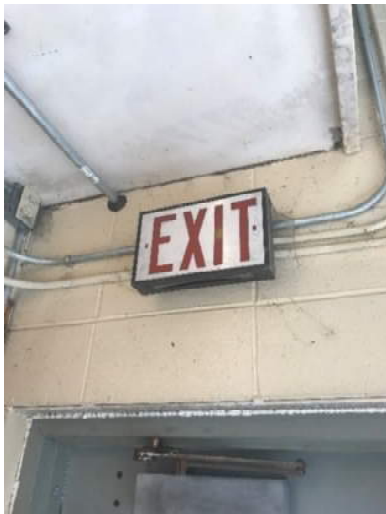
- Exit signs are illuminated (with the exception of one) but coverage is not adequate. The exit signs have approached their expected useful life.
- There is an existing exterior weatherproof enclosed propane generator, located in the exterior fenced-in area adjacent to the Mechanic's Service Garage. The generator was manufactured by Kohler. The rating of the generator is 100KW, 120/240V, 1-phase. The generator backs up the entire facility except the air compressors. The employees manually shut off the breakers for the compressors. It appears to be in good working condition, is maintained annually, exercised weekly, was installed in 2000. Continuing the maintenance and exercising, the generator has an additional 12 to 15 years of expected life. The generator turns on automatically when there is a utility outage, via the existing 400 Amp Kohler Automatic Transfer Switch. The ATS also appears to be in good condition with an additional 12 to 15 years remaining.

Non-Illuminated Exit Sign - Corridor
