CONDITION ASSESSMENT AND RECOMMENDATIONS

Preservation of the Hildreth House

Harvard, Massachusetts

**FINAL DRAFT
October 11, 2004**

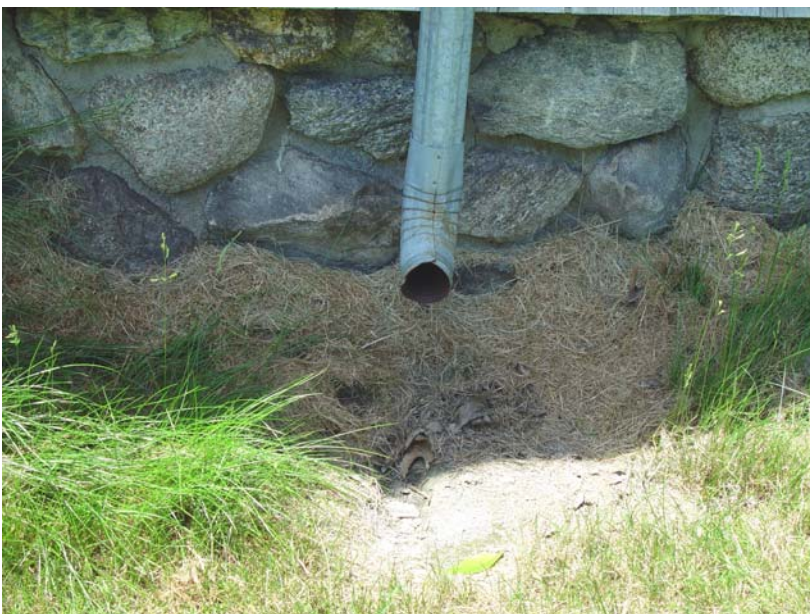
Fig. 11
East elevation conductor
discharge scours soil and
enters the crawlspace
through the foundation.

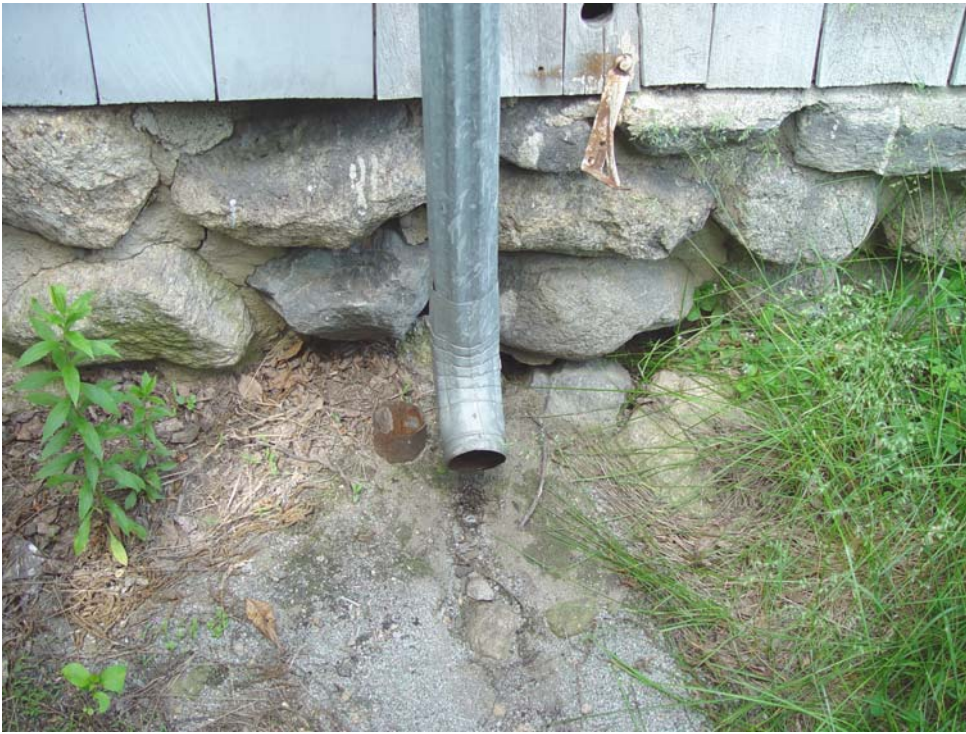
Fig. 12
South Elevation conductor discharge scours soil and enters the crawlspace through the foundation.

***R2.2-5** Reinstate drains serving the 3 south veranda conductors so that water is received directly into respective historic cast iron boots and is piped through the veranda foundation wall into the crawlspace. Intercept the cast iron lines in the crawlspace with a new PVC trunk line directed through the west end of the south veranda foundation below grade, discharging to daylight sufficiently down the embankment to the west. Also install new cast iron boot and PVC drain to receive discharge from conductor at southwest corner of south elevation (adjacent to west veranda stair) and connect below grade to the new trunk serving the south veranda conductors. Cap and abandon in place the remaining portions of the cast iron drains. (\$5,250)*

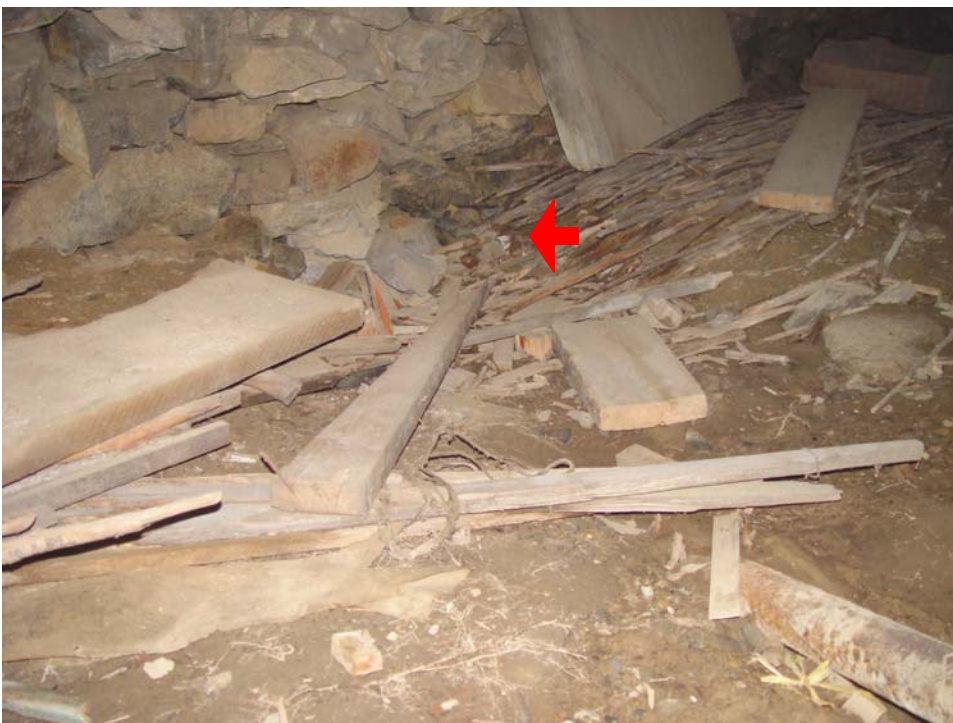
Fig. 13
Water traverses the south veranda crawlspace to gain entry into the cellar.

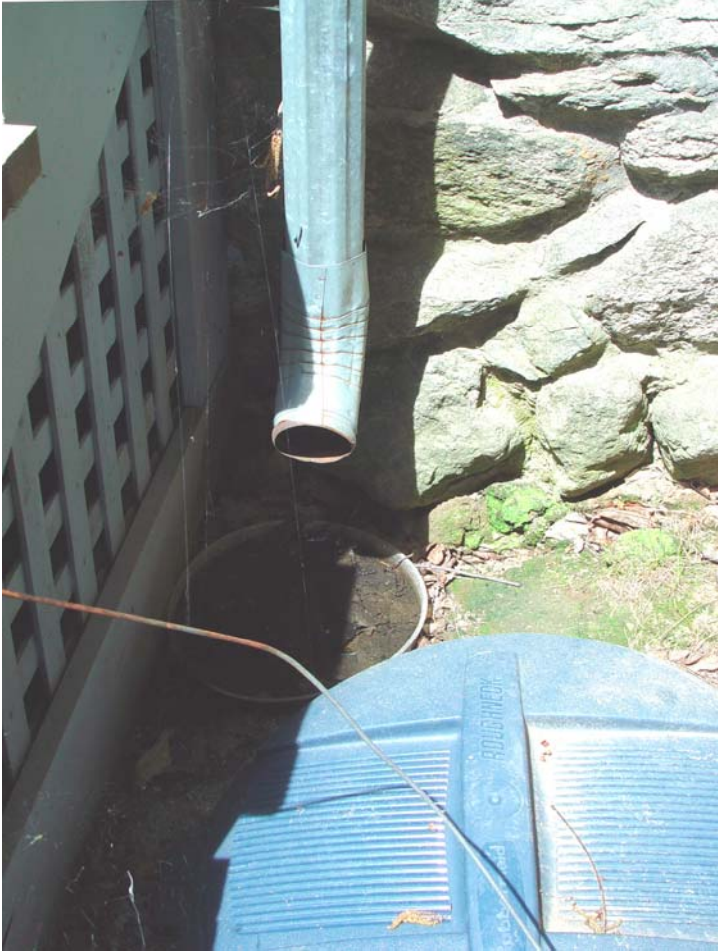
Fig. 14
Water discharge runs beneath
west veranda stair to left.

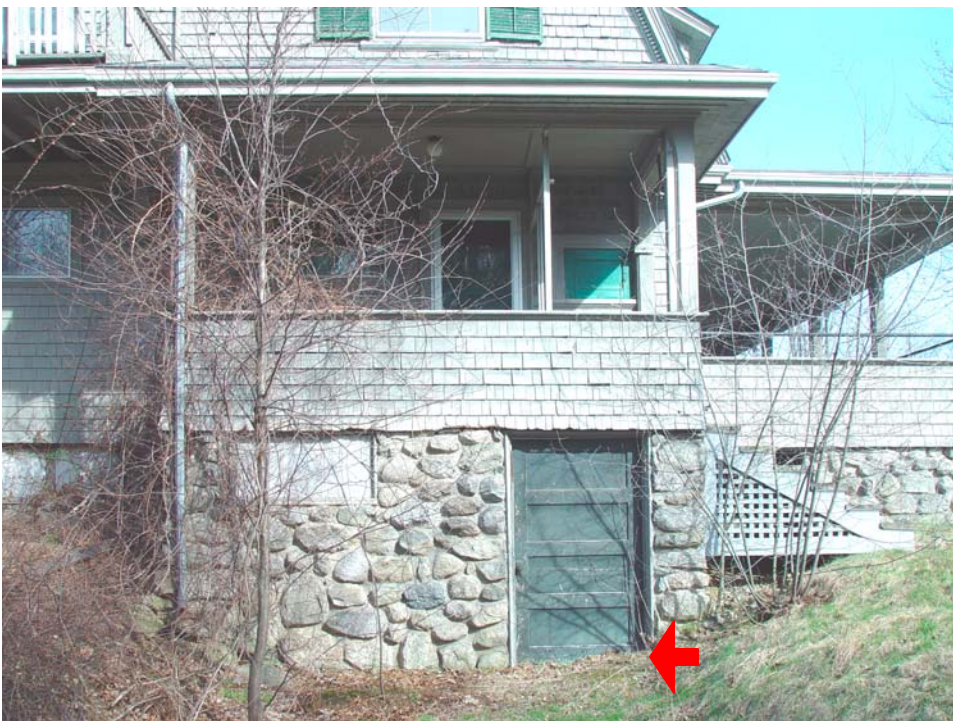
Fig. 15
Threshold and bottom rail of west cellar door lie partially buried in soil.

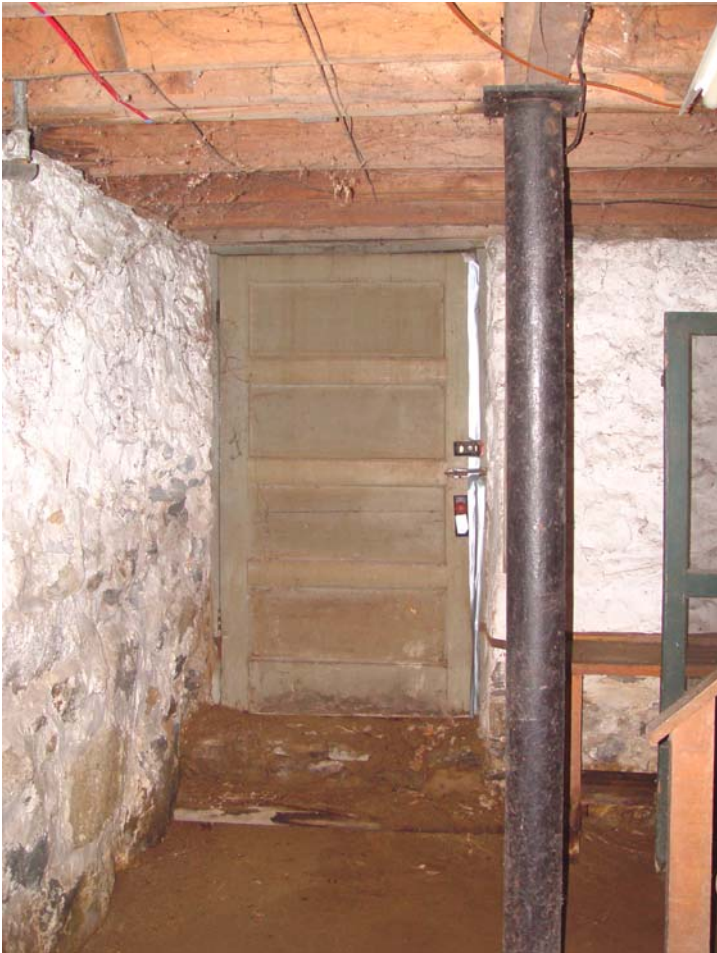
Fig. 16
Wet silt spreading over cellar
floor from beneath west cellar
door.

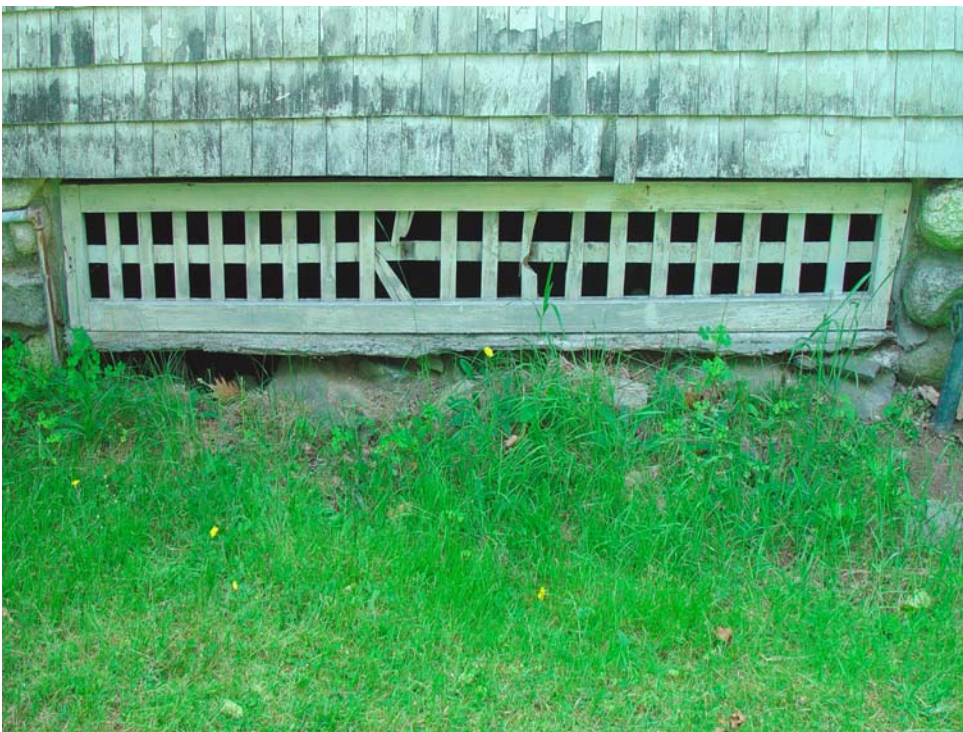
Fig. 17
Foundation stones missing from beneath lattice sill.

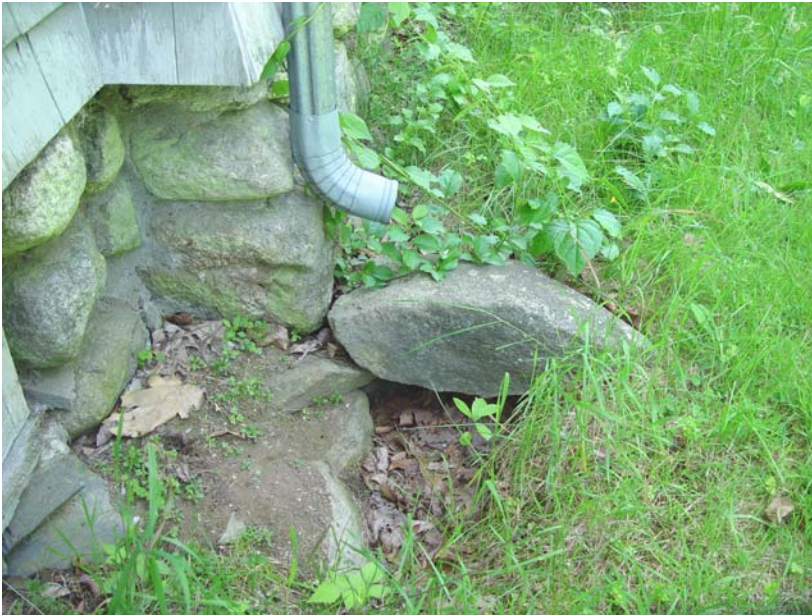
Fig. 18
Water discharge runs
directly into foundation.

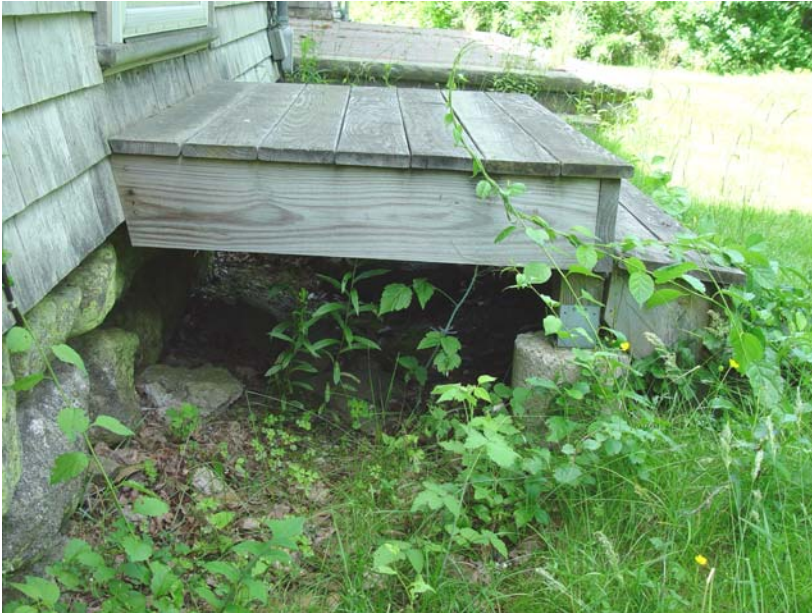
Fig. 19
Grade pitches into
foundation beneath
stoop.

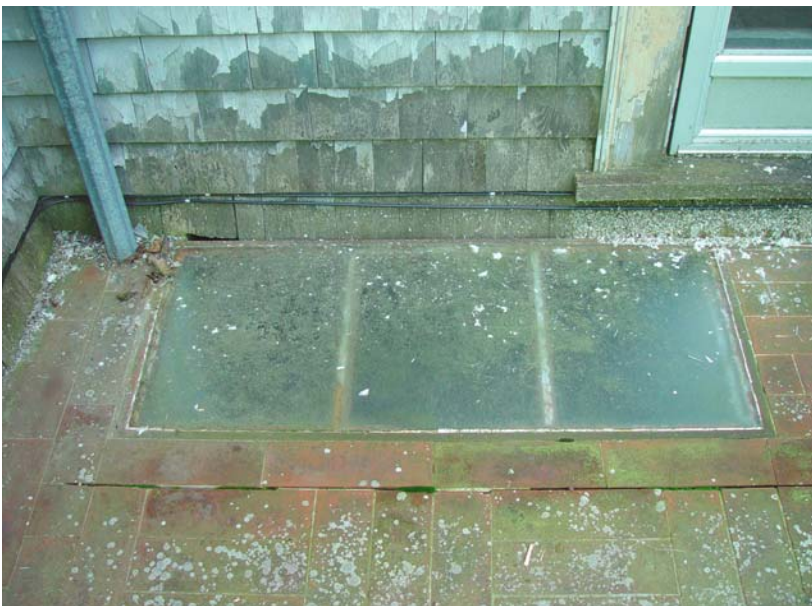
Fig. 20
Water finds entry along
juncture of terrace
pavement and wood
framed wall.

***R3.2-4** Carefully remove paving from a 1-foot wide zone along the entire length of engagement with the wood framed walls. Inspect the condition of the buried wood sheathing and framing, and replace deteriorated elements with borate-treated materials as required. Reinstall masonry paving incorporating a membrane and a 1-inch air gap between paving and wood elements. Cover open top of the air gap with lead-coated copper counter flashing integrated into the base course of shingles above.* (\$6,150)

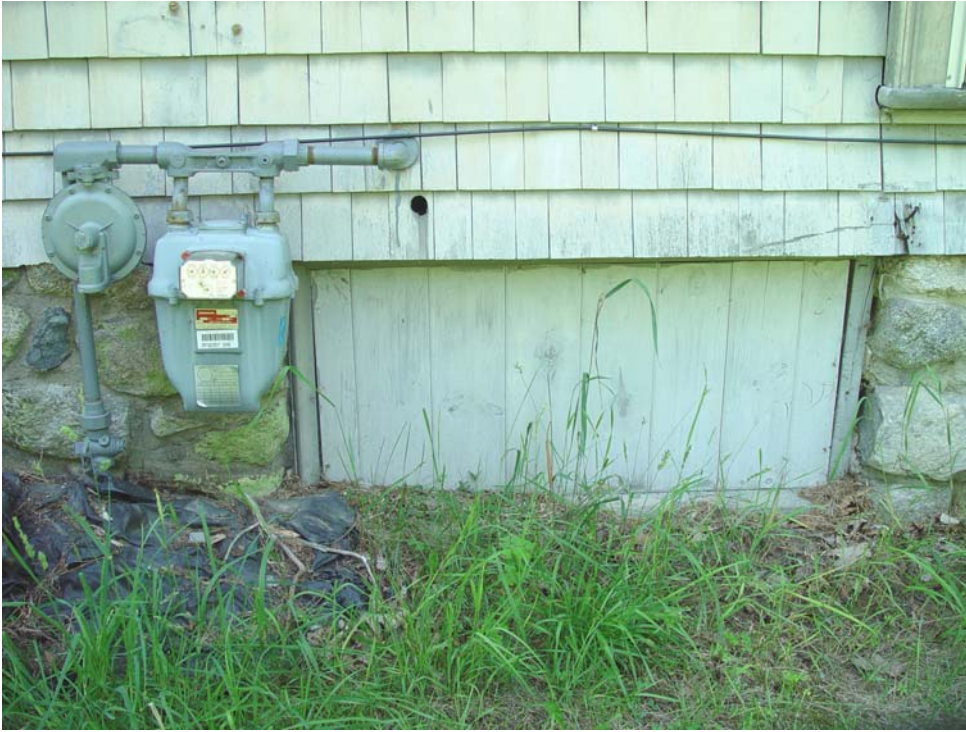
Fig. 21
Sill of boarded cellar window is partially buried in earth.

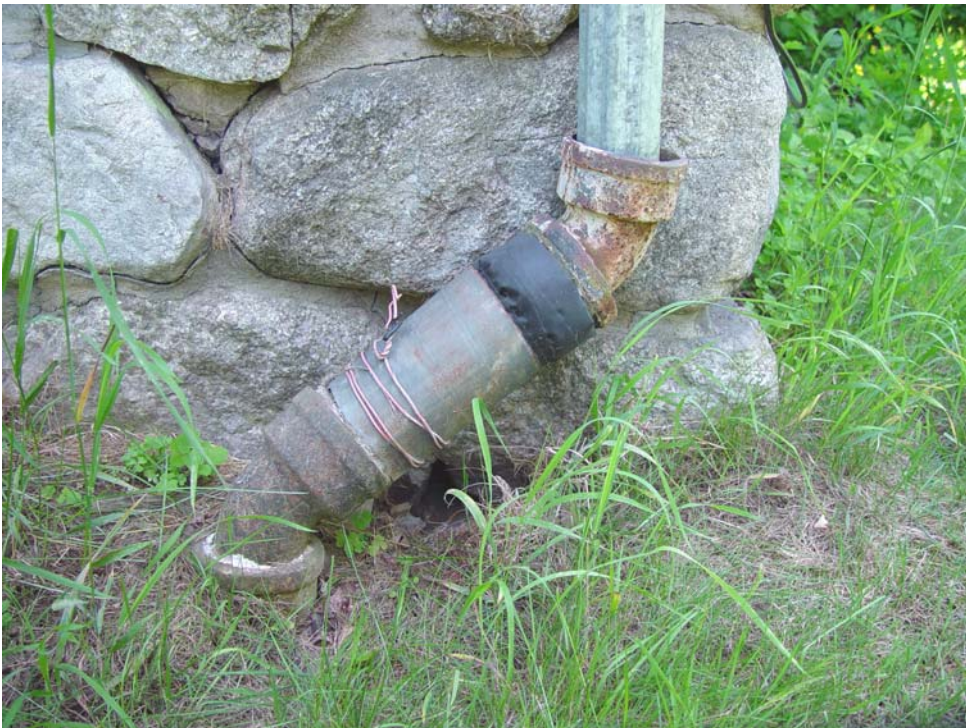
Fig. 22
Drain connection haphazardly patched to remedy water scouring and penetrating foundation.

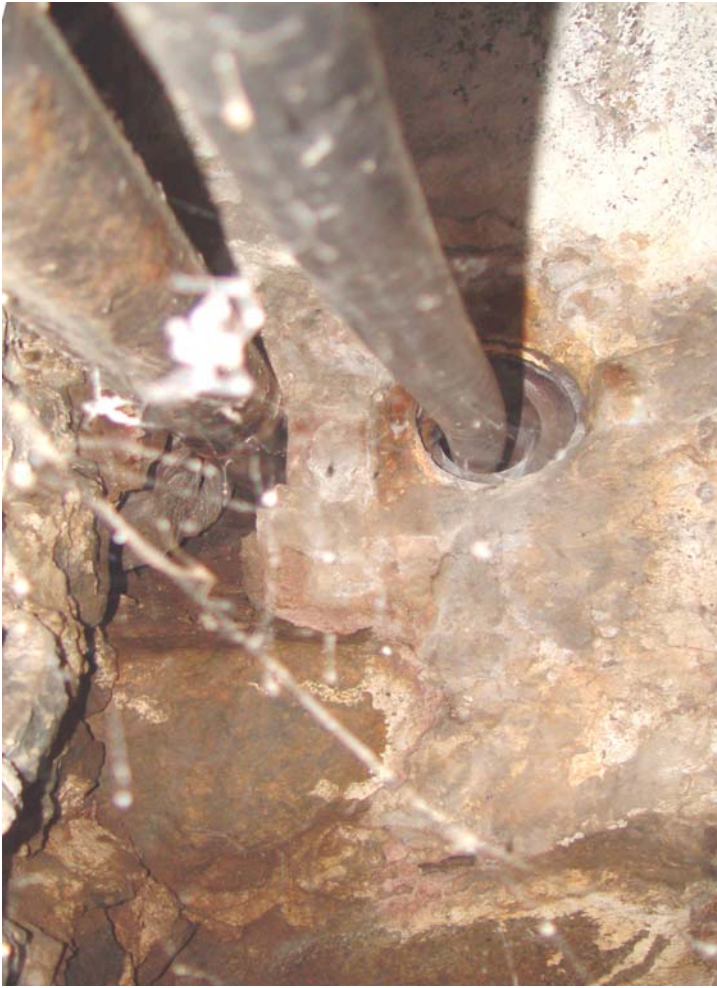
Fig. 23
Water infiltrates the foundation wall at the entry of the northwest conductor drain.

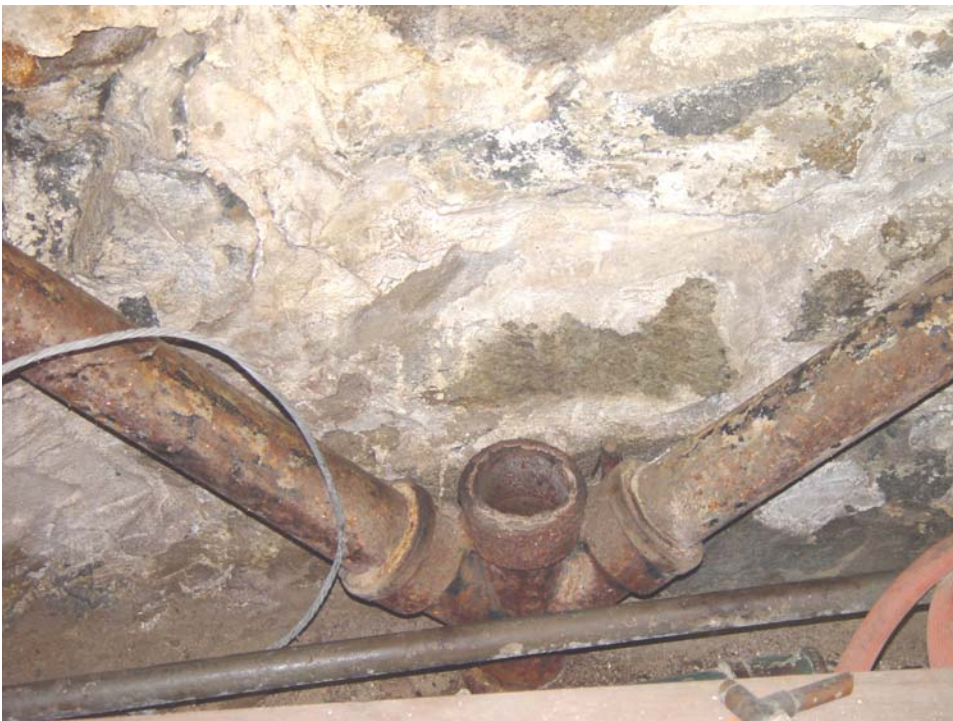
Fig. 24
Open leg of conductor drain wye fitting allows overflows into cellar.

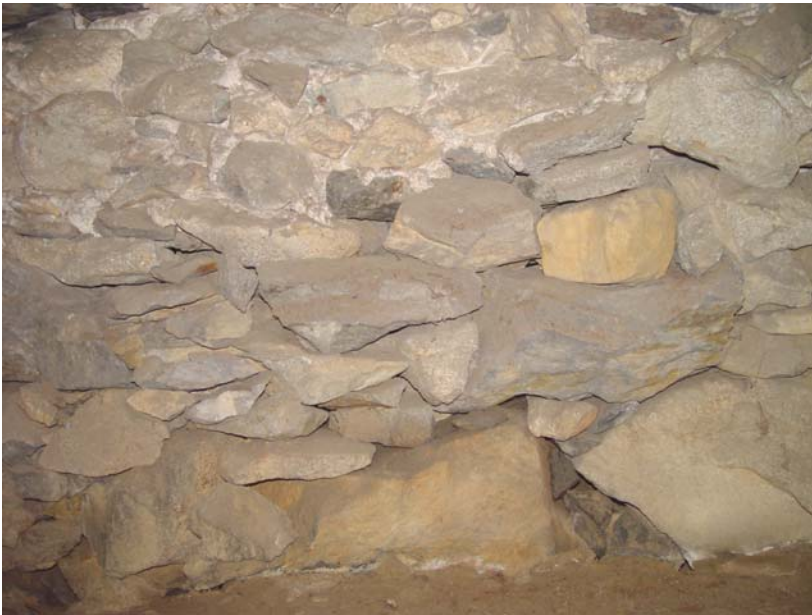
Fig. 26
Foundation masonry
with only uppermost
courses pointed, as
viewed from veranda

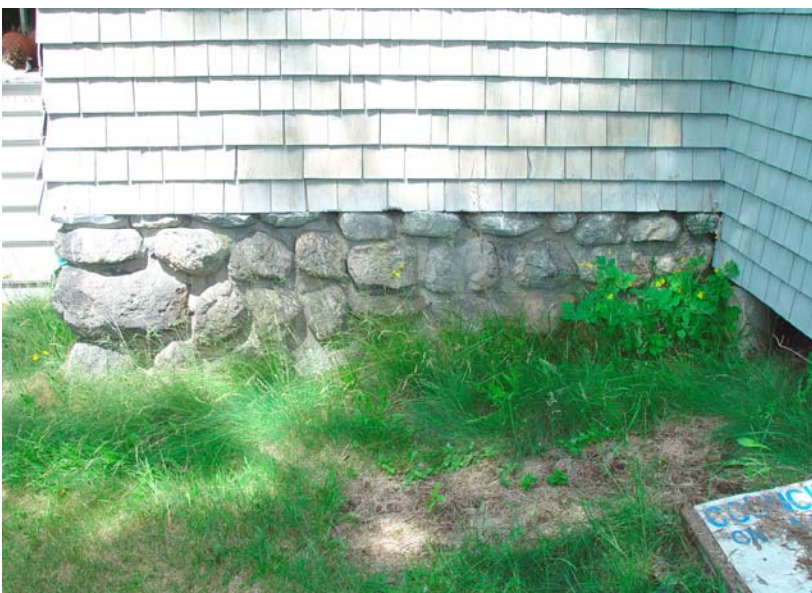
Fig. 27
Repair mixes not well
matched to historic
mortar.

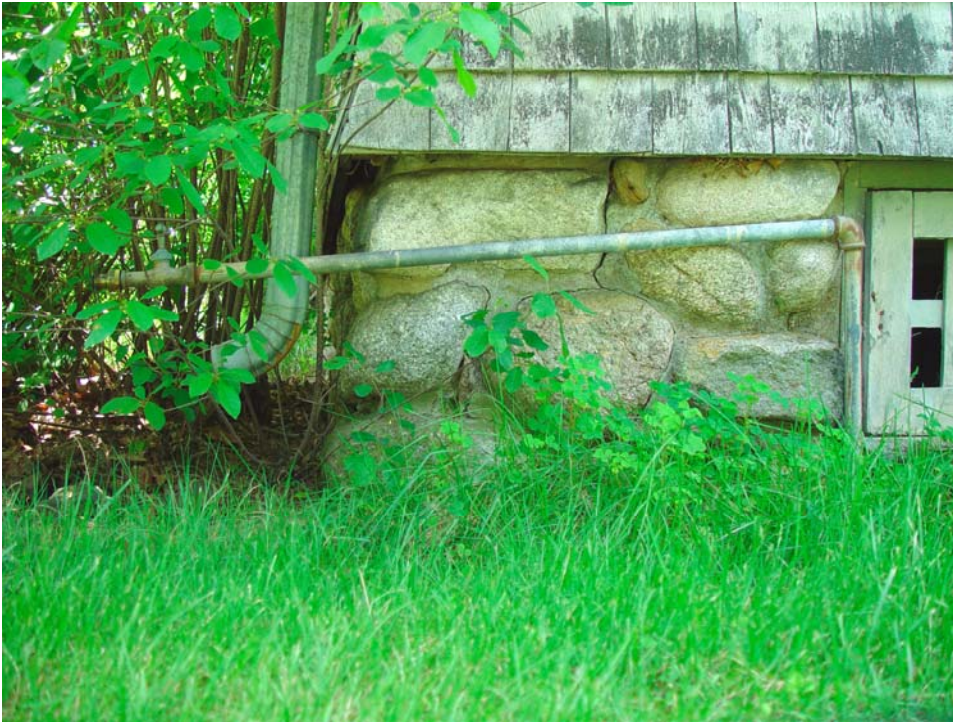
Fig. 28
Shrinkage cracks in upper courses and erosion of mortar near grade typical on easterly reaches of north elevation.

***R3.1-1** Repoint the easterly end of the north elevation with appropriate sand-lime mix (approximately 30% of surface area), addressing open and extensively weathered joints, as well as inappropriate prior Portland cement repairs. Recover and reset missing foundation stones beneath the sill of the latticed opening at the northerly end of the east veranda.* (\$ 650)

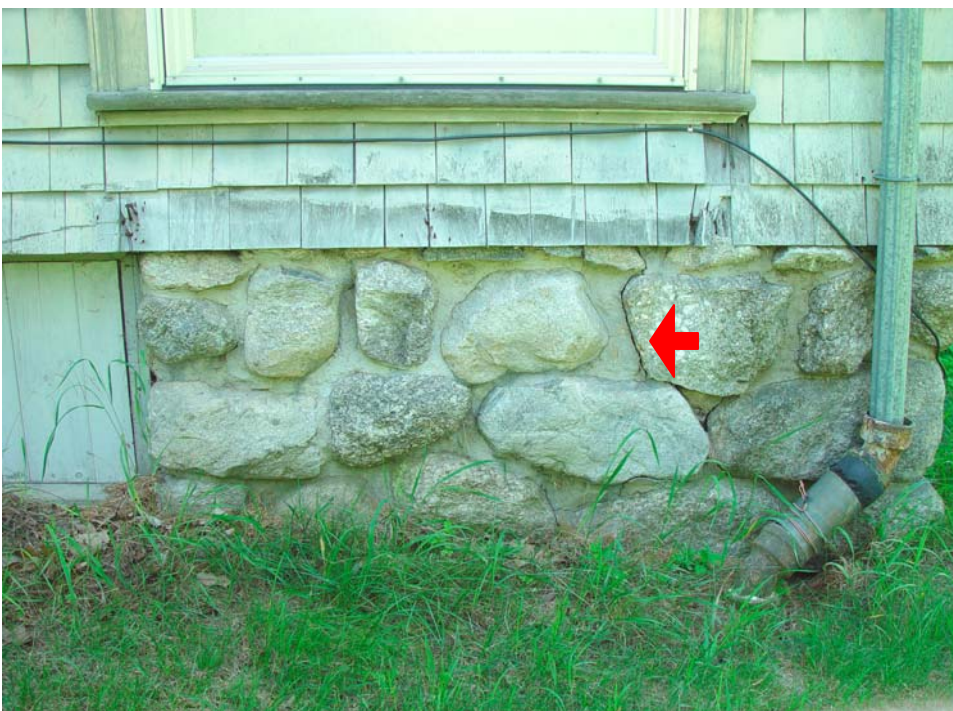
Fig. 29
Settlement cracking in mortar joints at northwest corner.

***R3.1-3** Repoint developed settlement cracks at the northwest corner of the north elevation, and the southwest corner of the south veranda with appropriate sand-lime mix. Reset displaced stones and repoint northwest corner of west veranda. Localized excavation may be required to reveal the full extent of the cracking systems and displacements. Also repoint interior northwest corner of cellar wall at corresponding crack location.* (\$1,150)

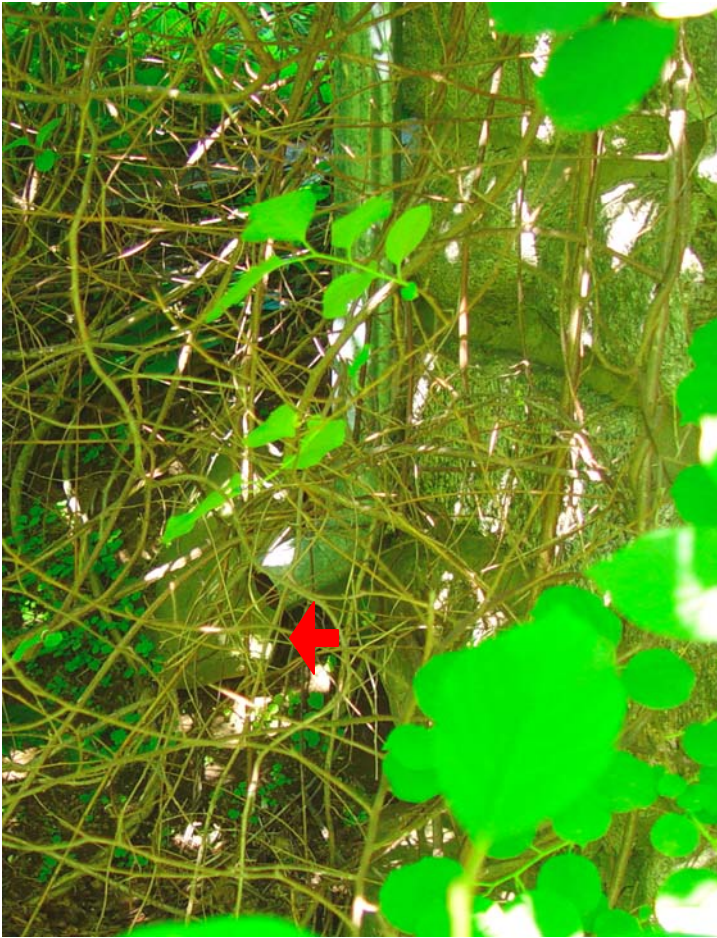
Fig. 30
Stones displaced at northwest
corner of west veranda
foundation.

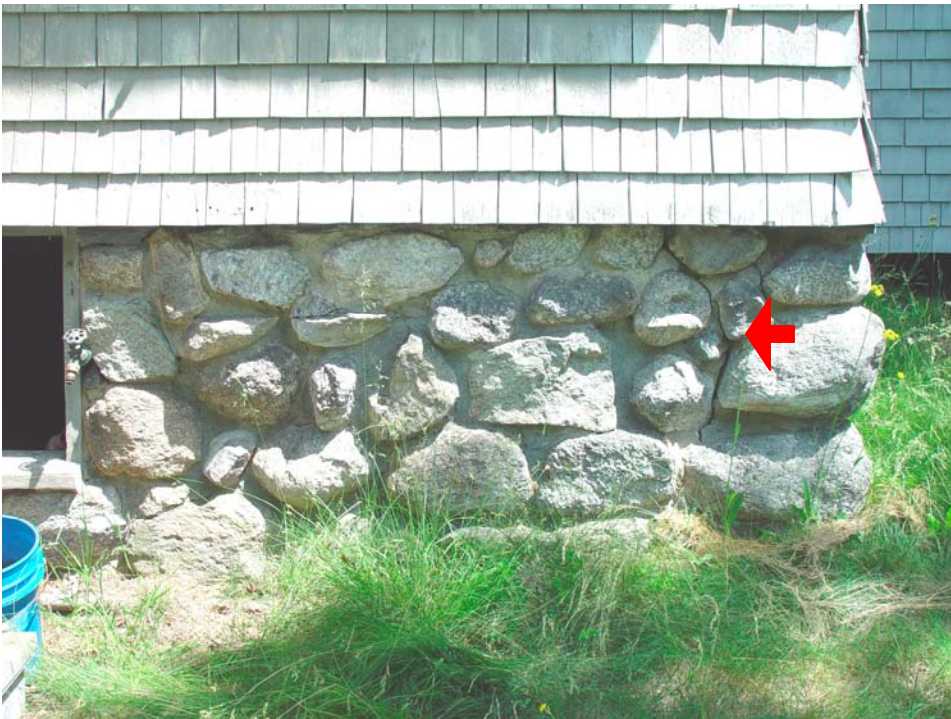
Fig. 31
Settlement cracking in mortar joints at southwest corner of south veranda.

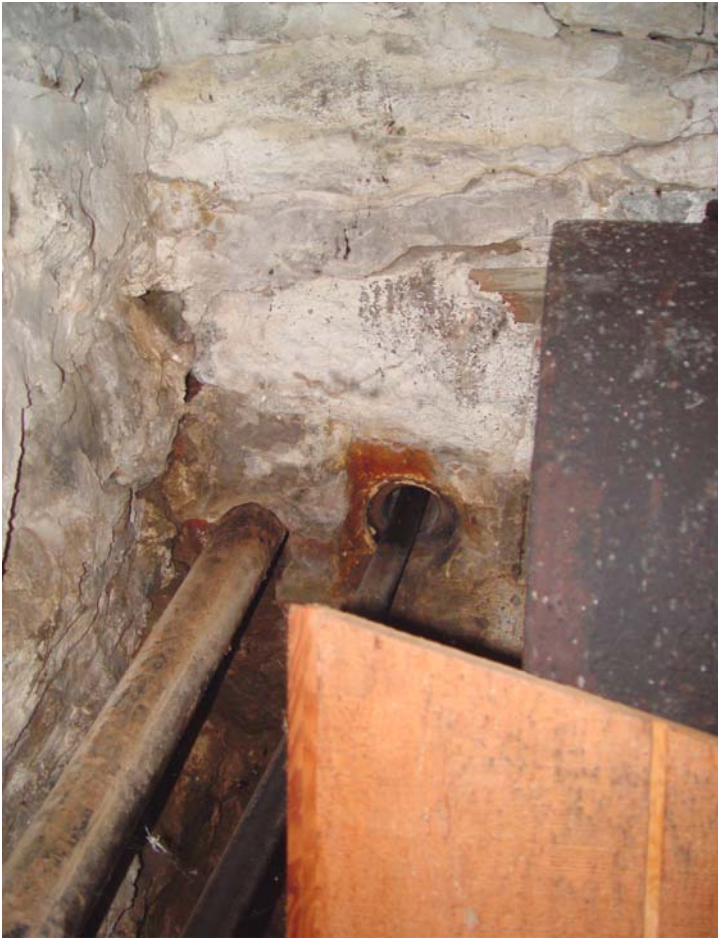
Fig. 32
Examples of foundation wall
penetrations in need of sealants.

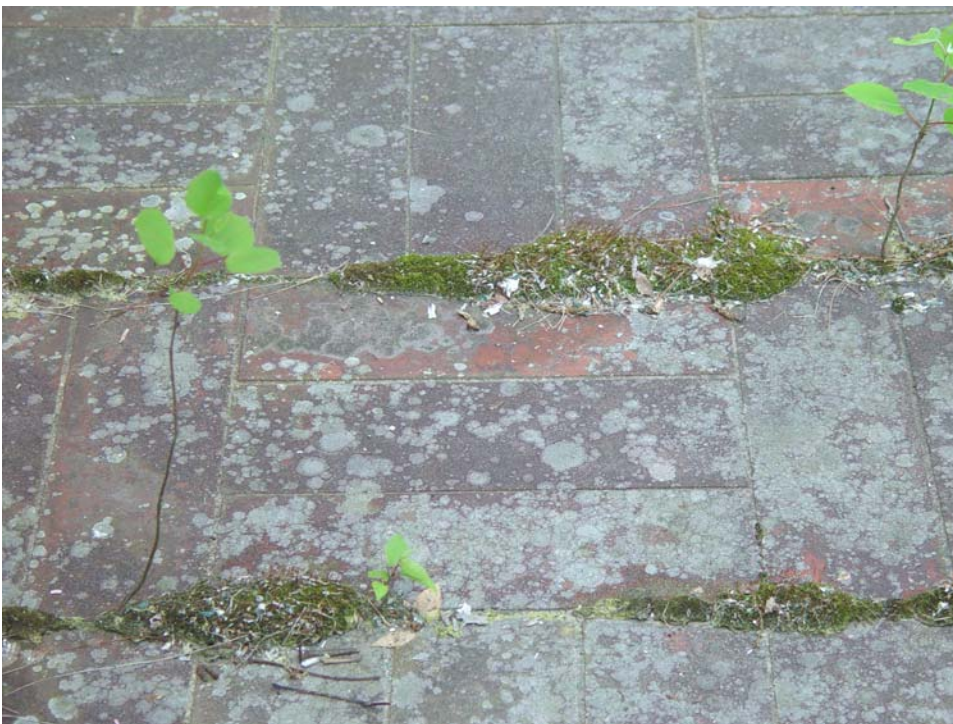
Fig. 35
Heavy organic growths in joints of terrace paving.

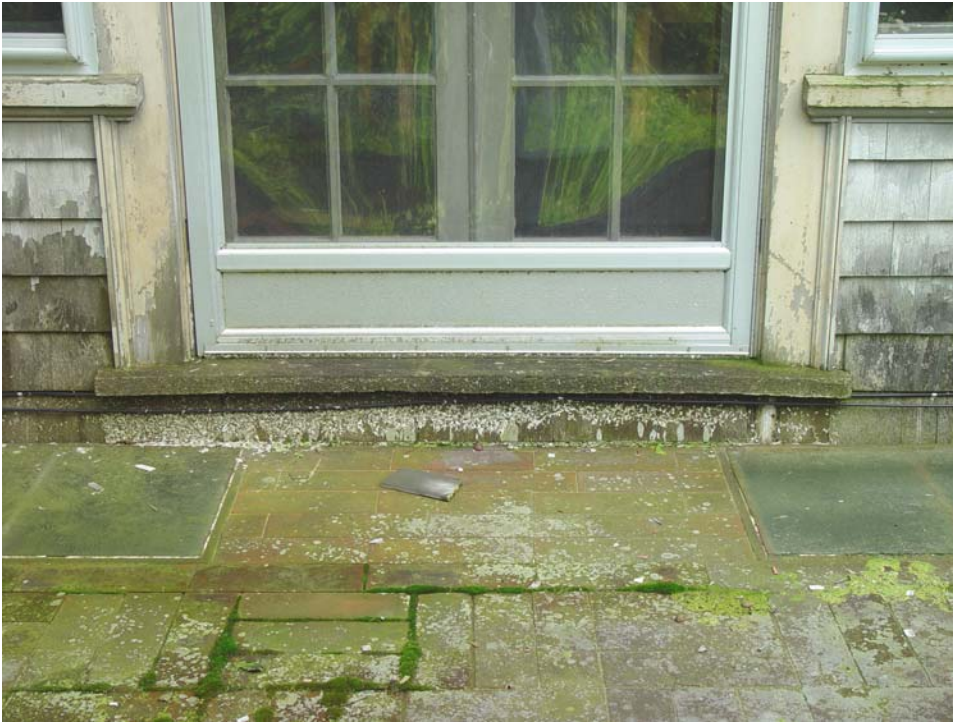
Fig. 36
Arching of door threshold providing circumstantial evidence of deteriorated building sill at north terrace.

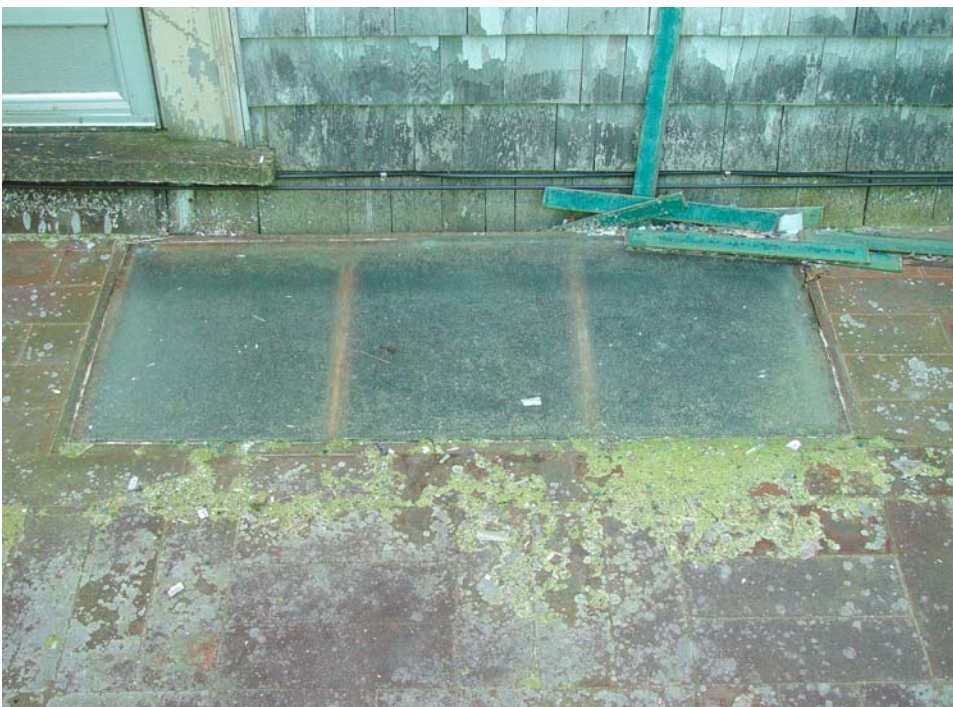
Fig. 37
Corroding iron frames of areaway covers.

***R3.2-3** Remove areaway glazing to access the respective iron frames. Remove loose corrosion, passivate the surfaces, prime with a zinc-rich primer, and*

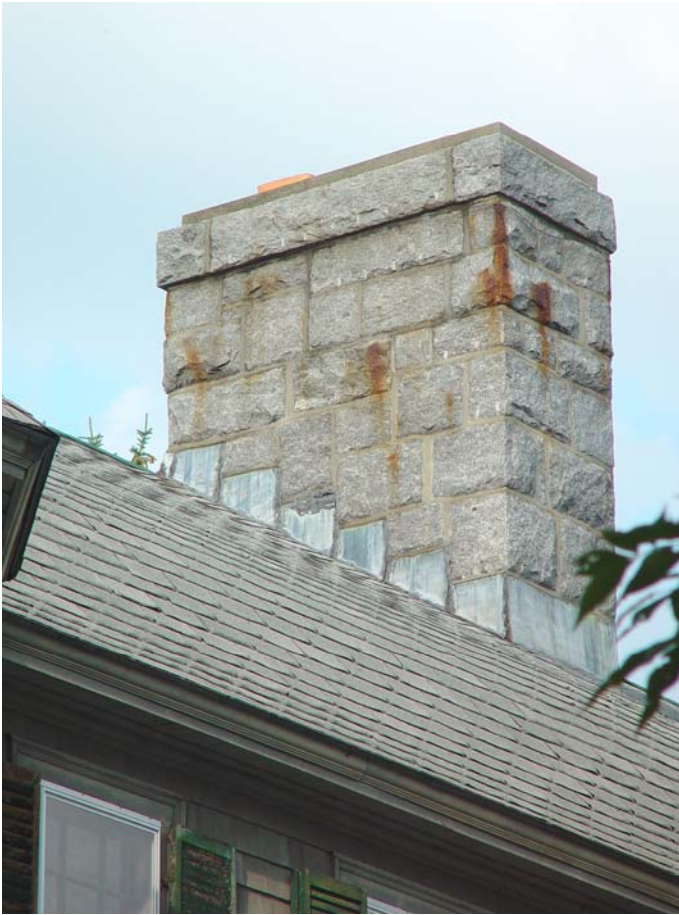
Fig. 38
Ferrous stains emanating from
abandoned trellis on east chimney.

***R3.3-1** When the south slopes of the main gambrel roof are resingled, document and remove the ferrous trellis system and associated anchors. Inspect and provide repairs to caps and flues as required. Repoint deteriorated masonry joints (presuming approximately 30% of surface area), and point in new lead counter flashings to receive base flashings provided during the resingling.* (\$5,850)

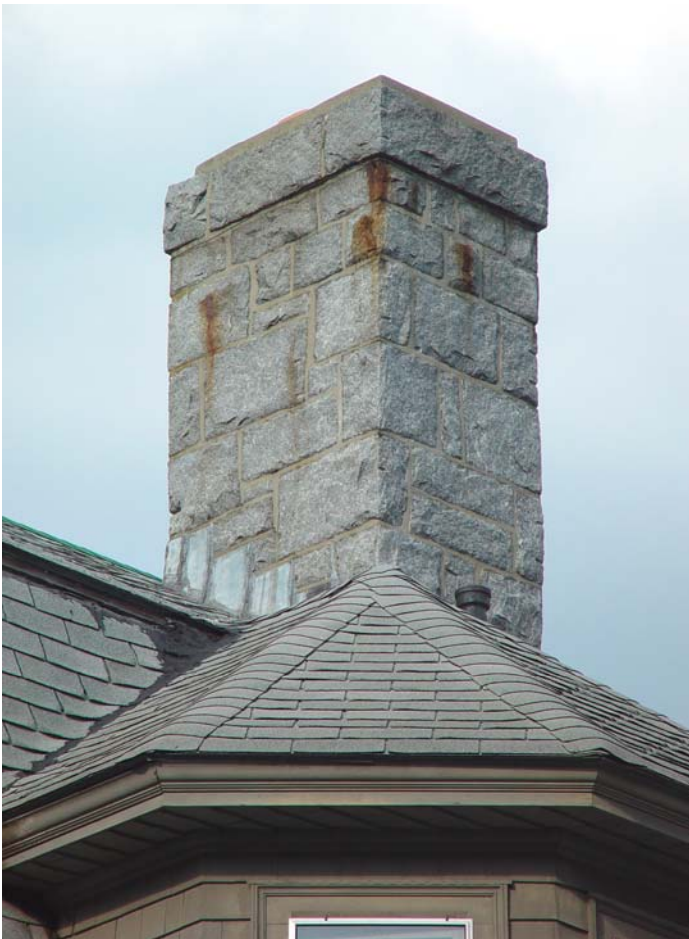
Fig. 39
Ferrous stains emanating from
abandoned trellis on west chimney.

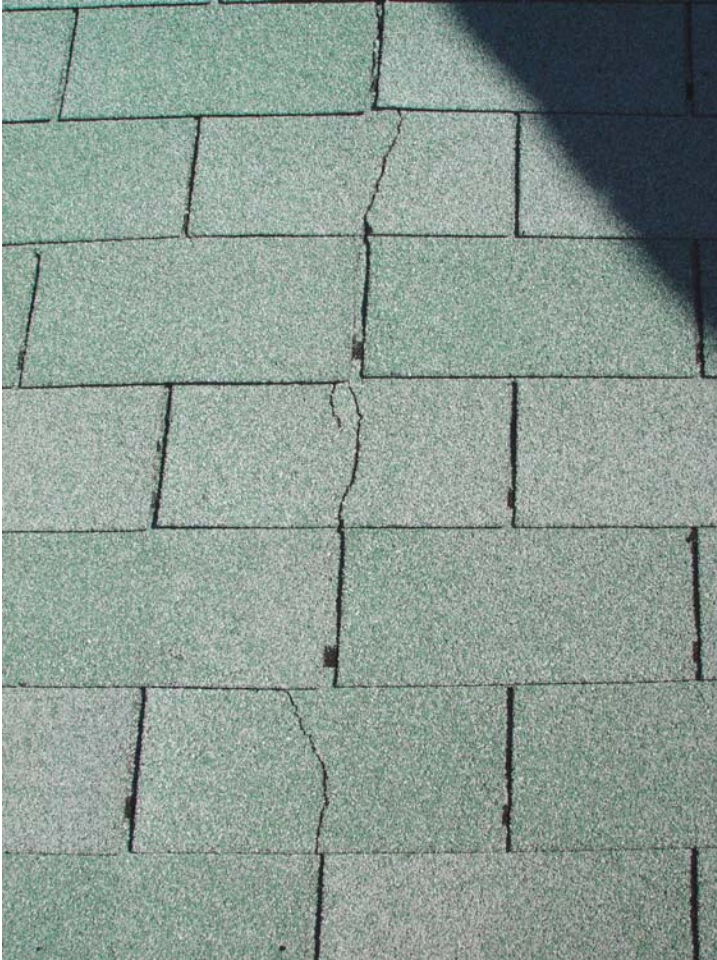
Fig. 42
Vertical cracking across shingle
courses of south veranda roof.

***R3.4-2** Remove existing and replace shingles on the south, east, and west veranda roofs, also replacing in-kind any deteriorated roof sheathing encountered. Incorporate new lead coated copper base and apron flashings at junctures with adjacent roof and wall planes. Underlay all flashings, as well as all ridges and eaves with bituminous polyethylene membrane.* (\$9,590)

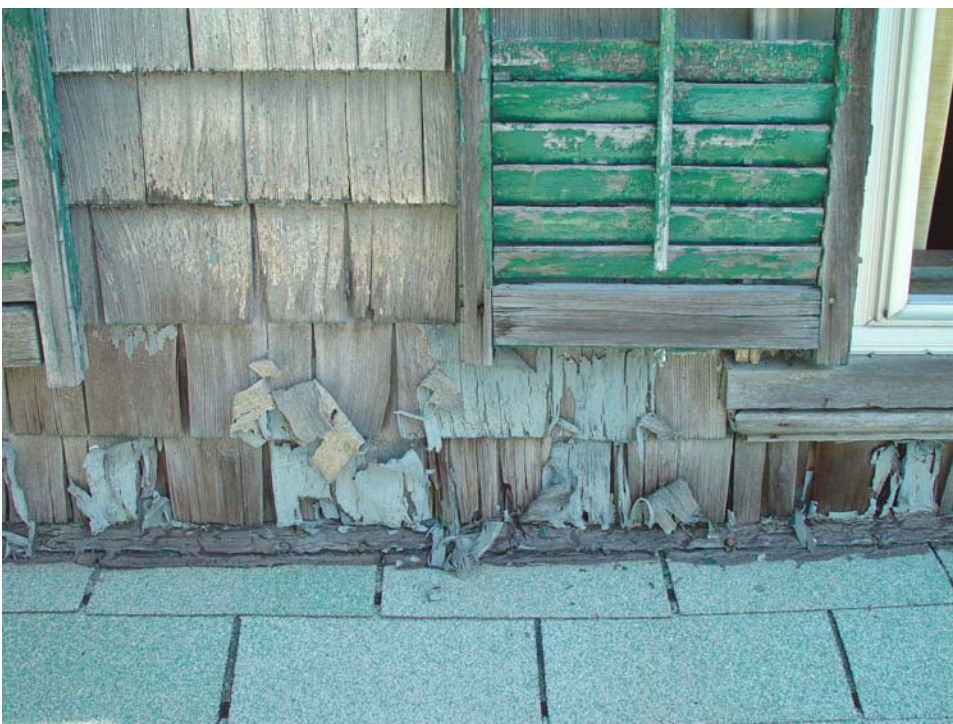
Fig. 43
Juncture of roofing and wall shingles vulnerable to water infiltration.

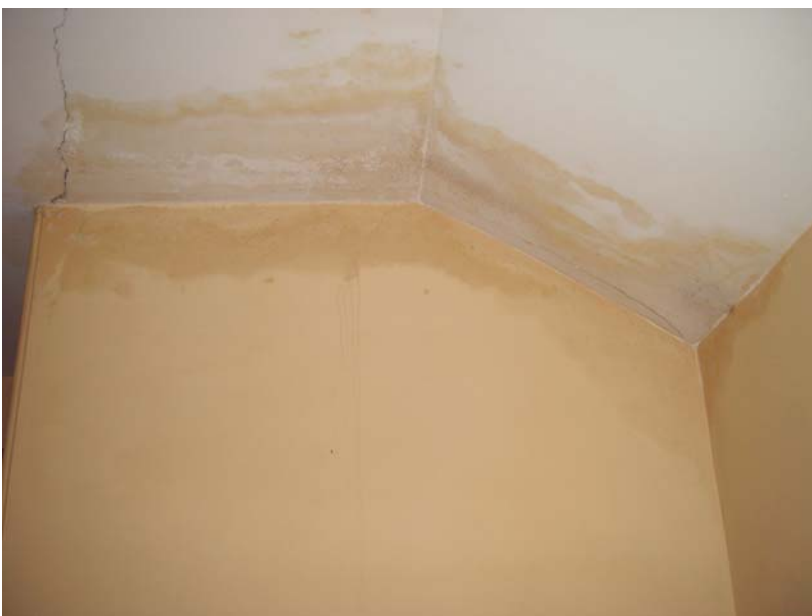
Fig. 48
Leakage along the west
face of the east chimney.

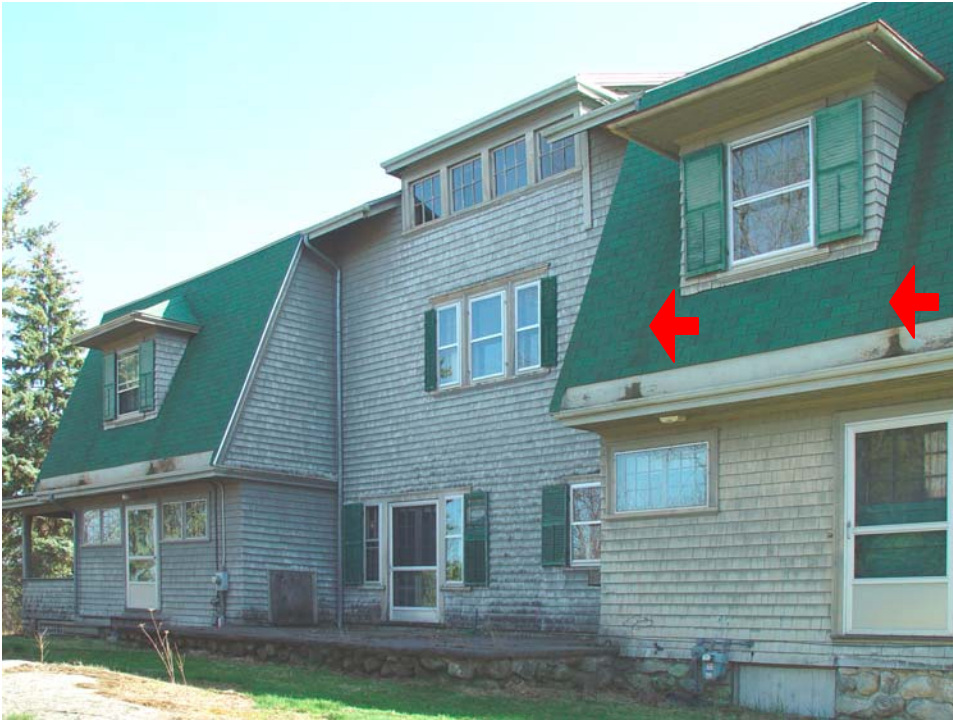
Fig. 51
Rusted galvanized gutter on north elevation west dormer creating pronounced staining on roof shingles.

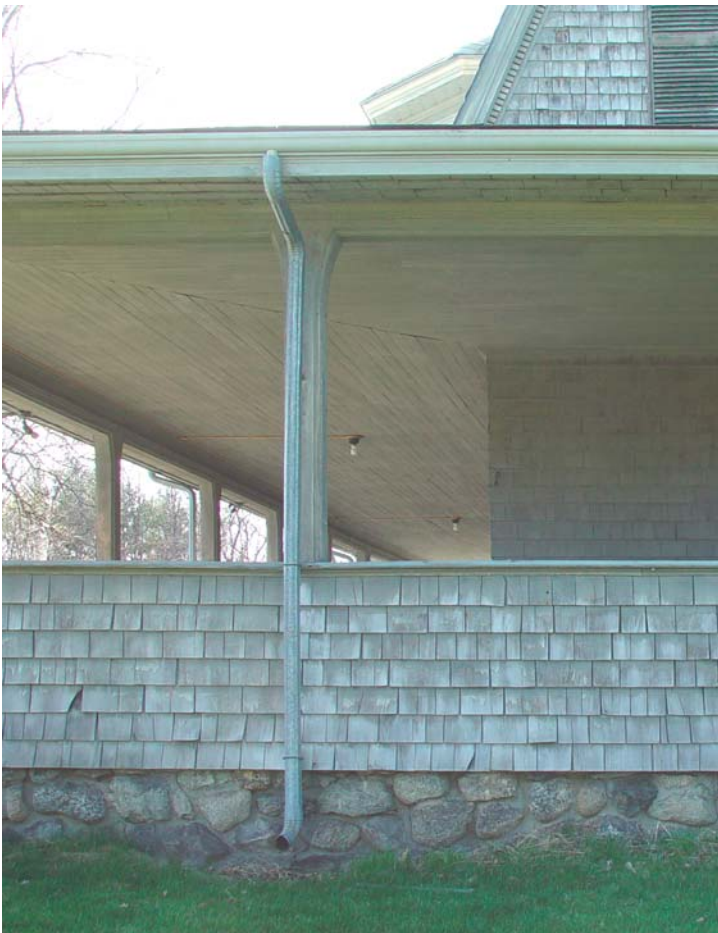
Fig. 52
Discharge elbow of galvanized conductor set high off the ground.

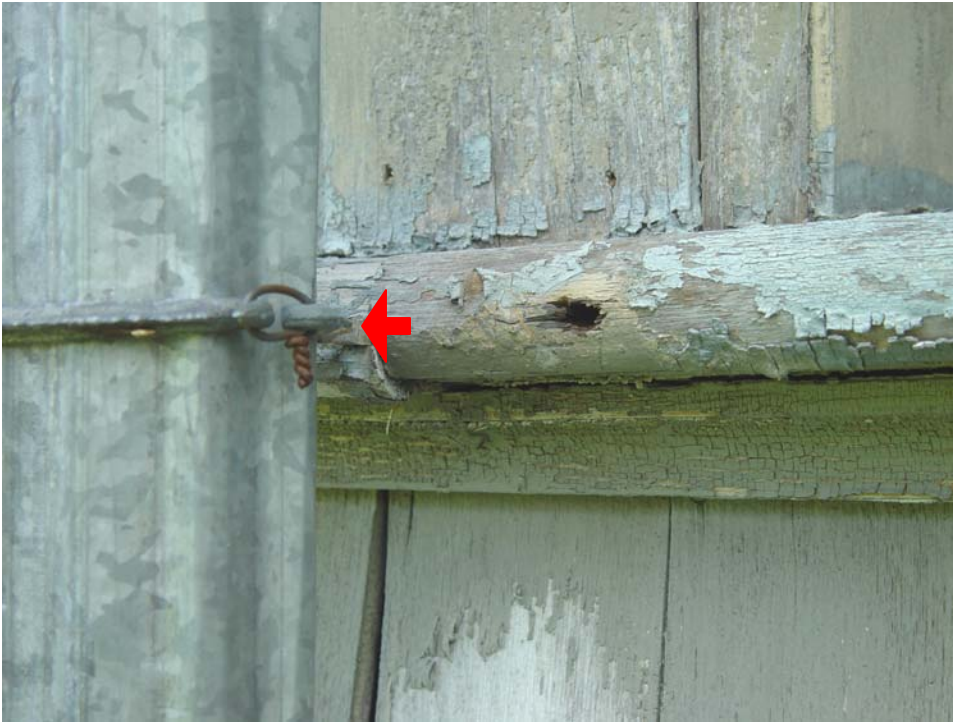
Fig. 53
Pintle of conductor bracket driven into edge of veranda parapet cap.

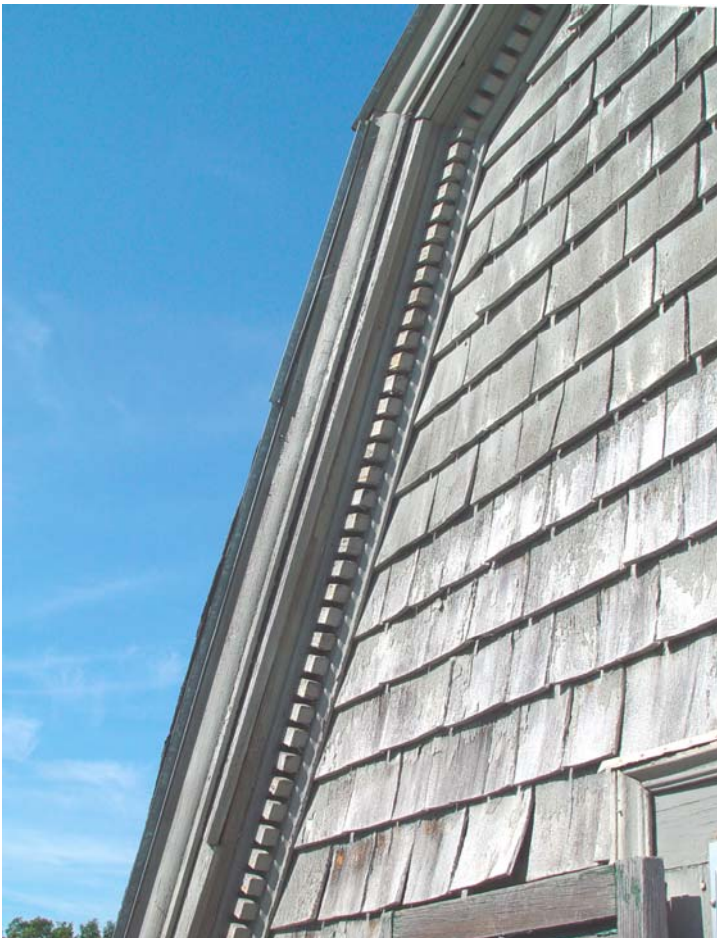
Fig. 54
Failed fastenings and open joints in gambrel rake trim.
