CONDITION ASSESSMENT AND RECOMMENDATIONS

Preservation of the Hildreth House

Harvard, Massachusetts

**FINAL DRAFT
October 11, 2004**

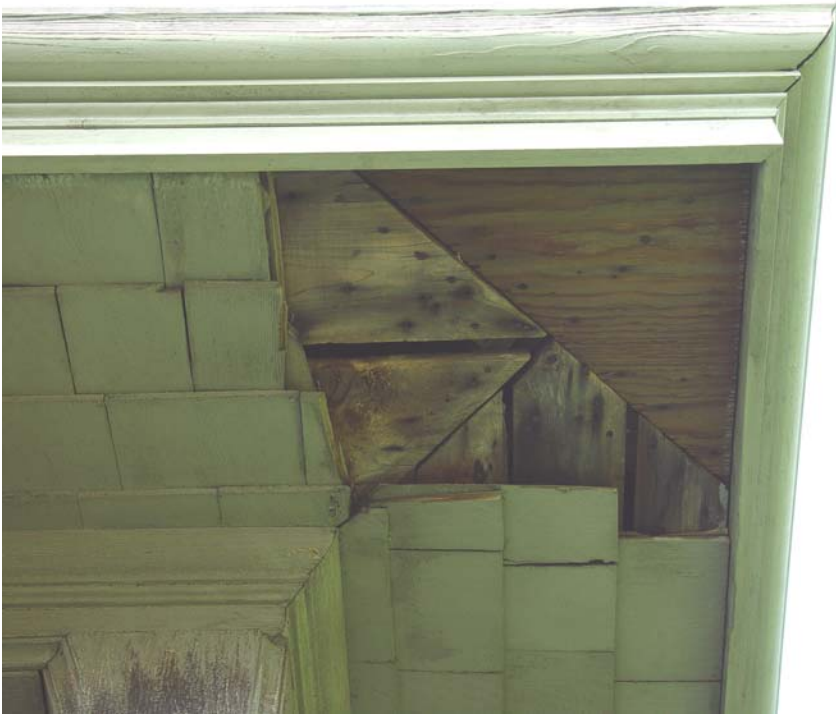
Fig. 55
Soffit shingles previously removed to enable reinforcement of sheathing.

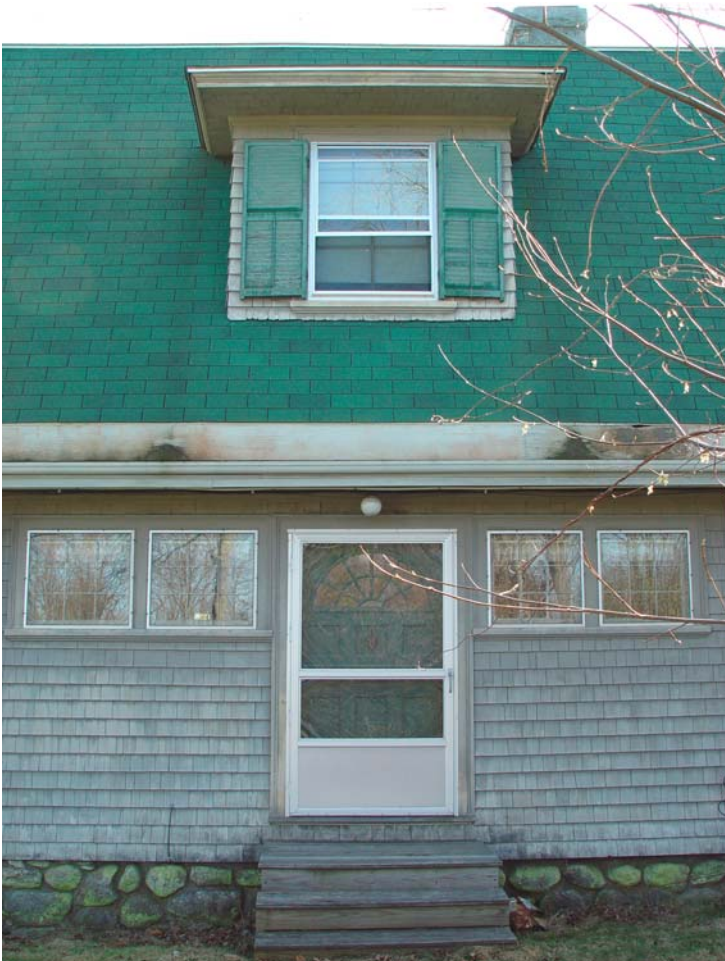
Fig. 56
Extensive deterioration of
fascia above north elevation
gutters.

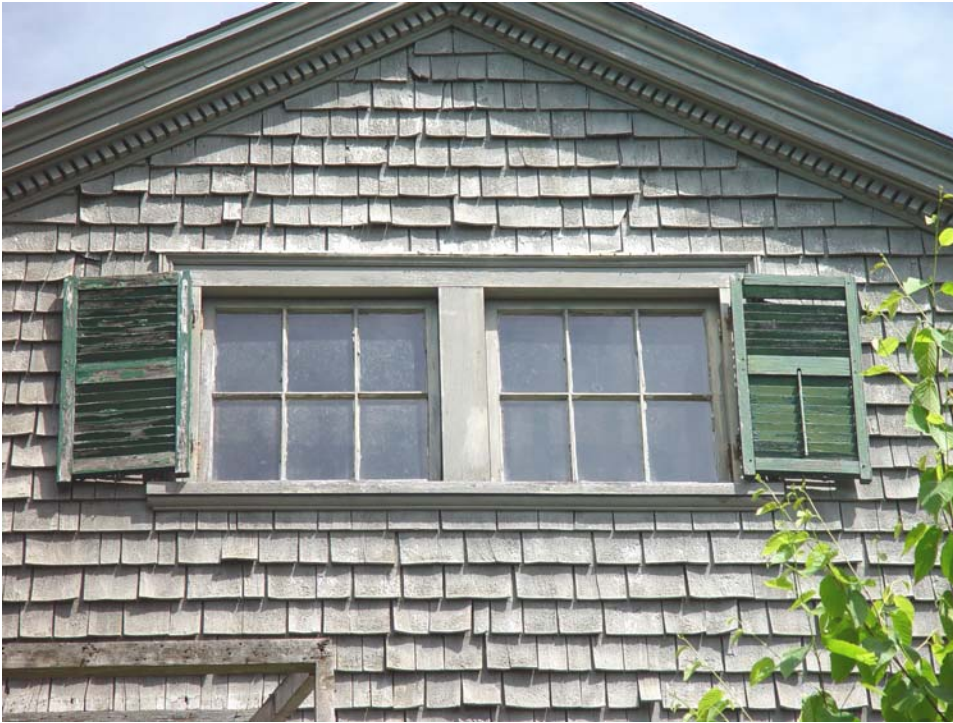
Fig. 57
Shingles in west gable subjected to deterioration from ultraviolet radiation.

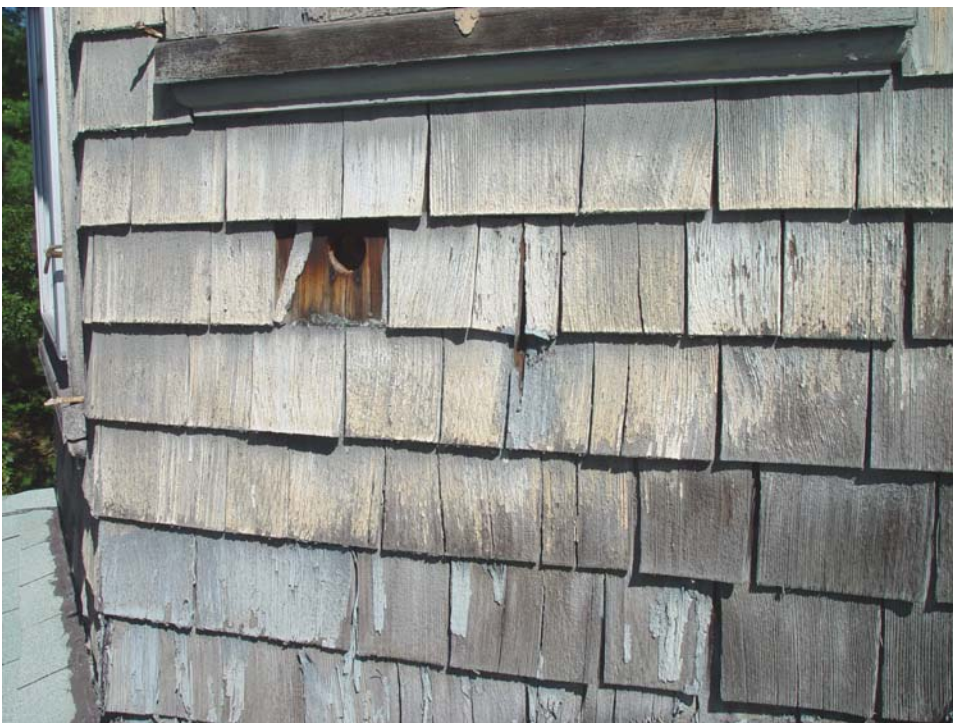
Fig. 58
Failure of face-nailed shingles at locations where blown-in insulation has been introduced.

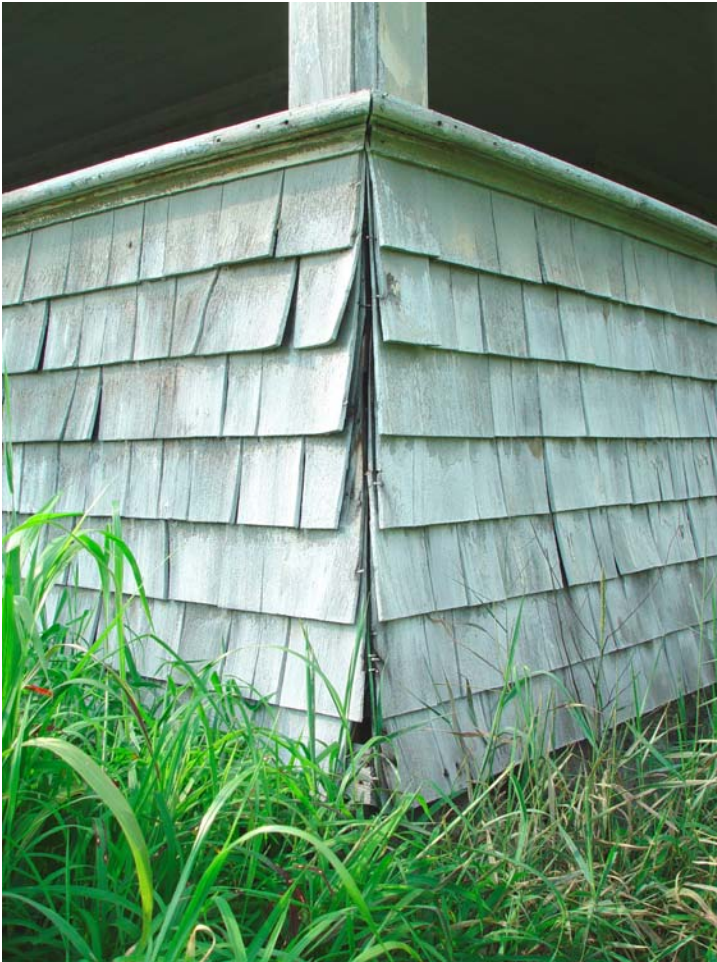
Fig. 59
Open and deteriorating
corners resulting from edge-
nailing of shingles.

***R3.7-5** Remove and replace individual shingles at outside corners where joints have opened or shingles have split due to inappropriate edge nailing. (\$ 180)*

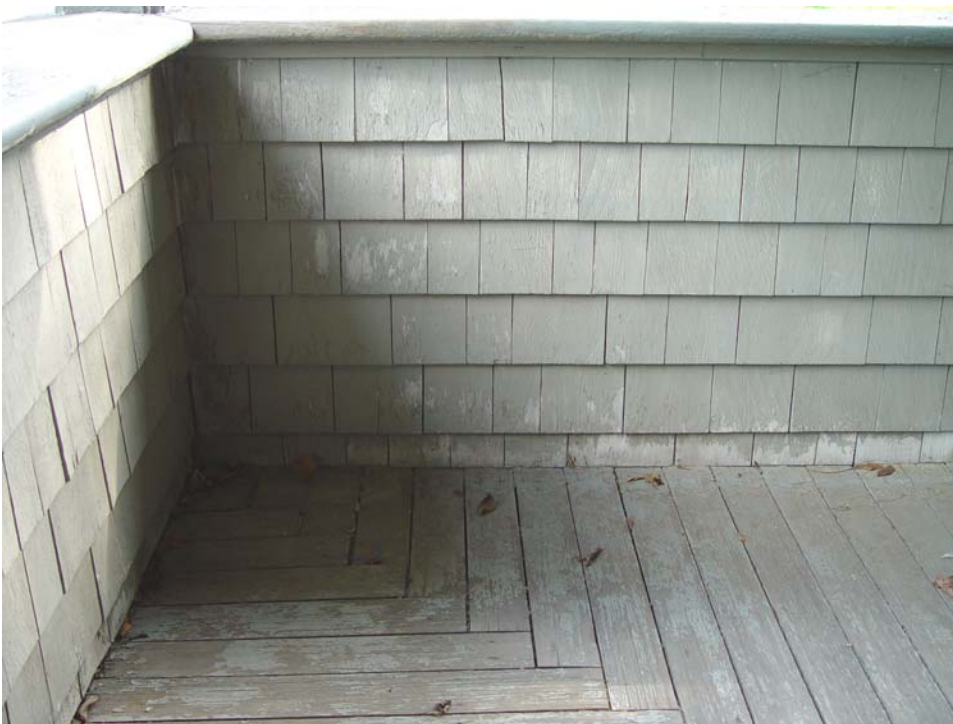
Fig. 60
Southeast corner of veranda where support conditions of flooring may be
marginal.

***R3.8-5** Carefully remove flooring at southeast corner of south veranda to inspect condition of framing. Augment support as required and reinstall flooring. Prepare, prime, and paint all veranda floors with gray deck enamel. (\$1,450)*

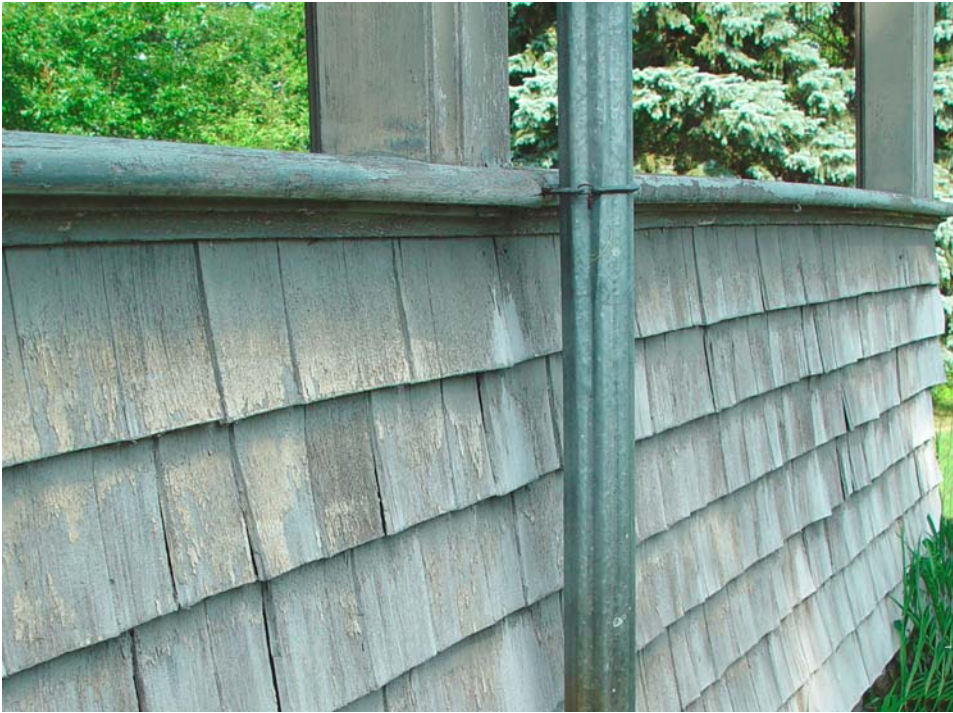
Fig. 61
Arched parapet caps suggesting post loads may be compressing the parapet sill.

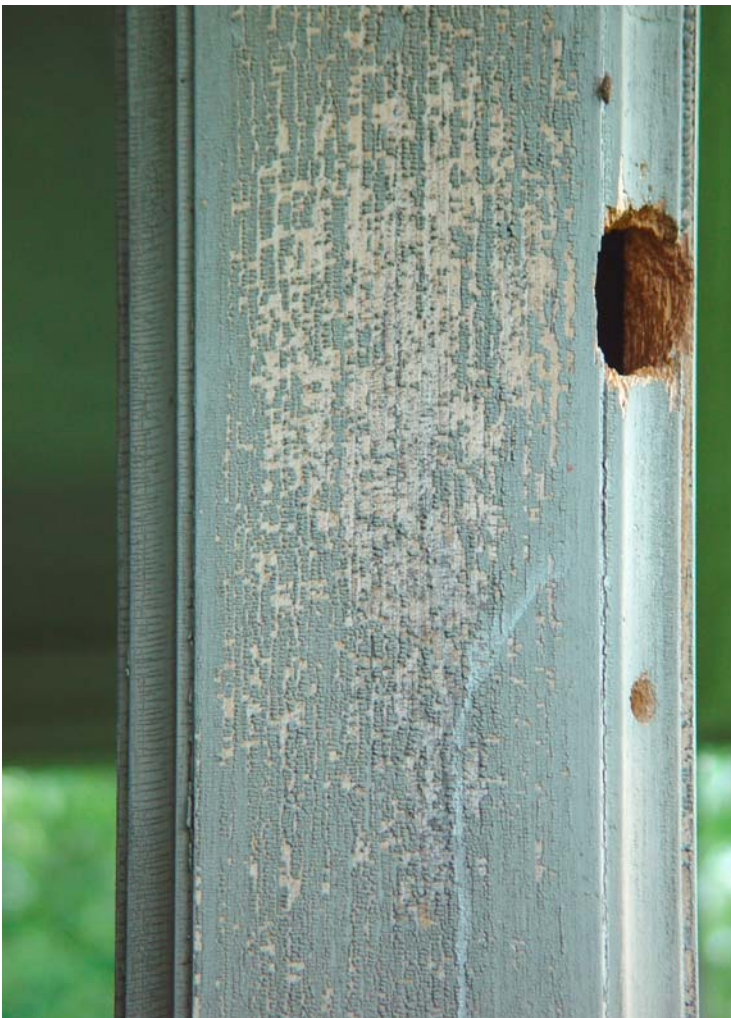
Fig. 62
Woodpecker holes in veranda post casings.

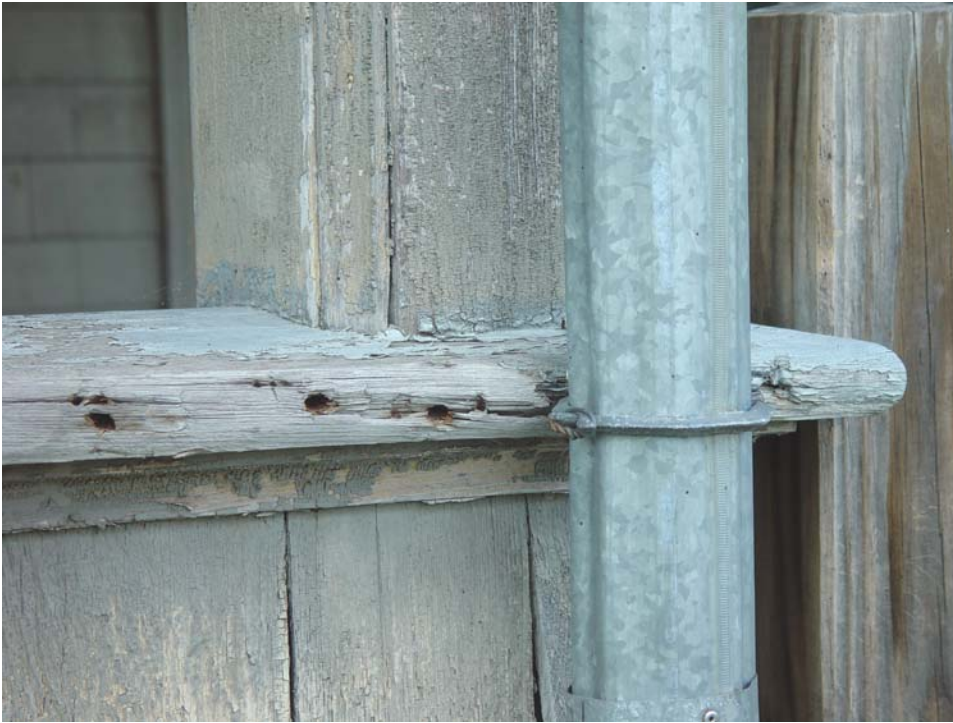
Fig. 63
Concentration of fasteners driven into edges of parapet caps.

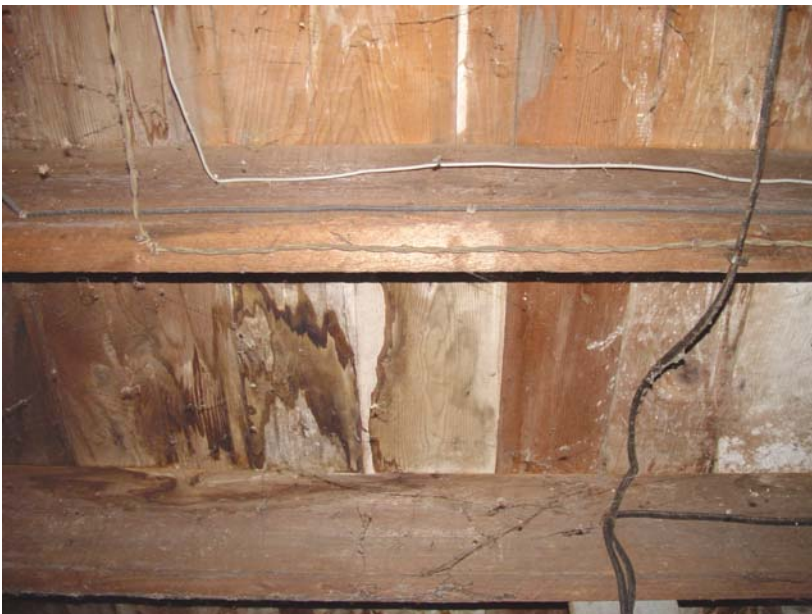
Fig. 67
Water stains on
underside of west
veranda sub flooring, as
viewed from cellar.

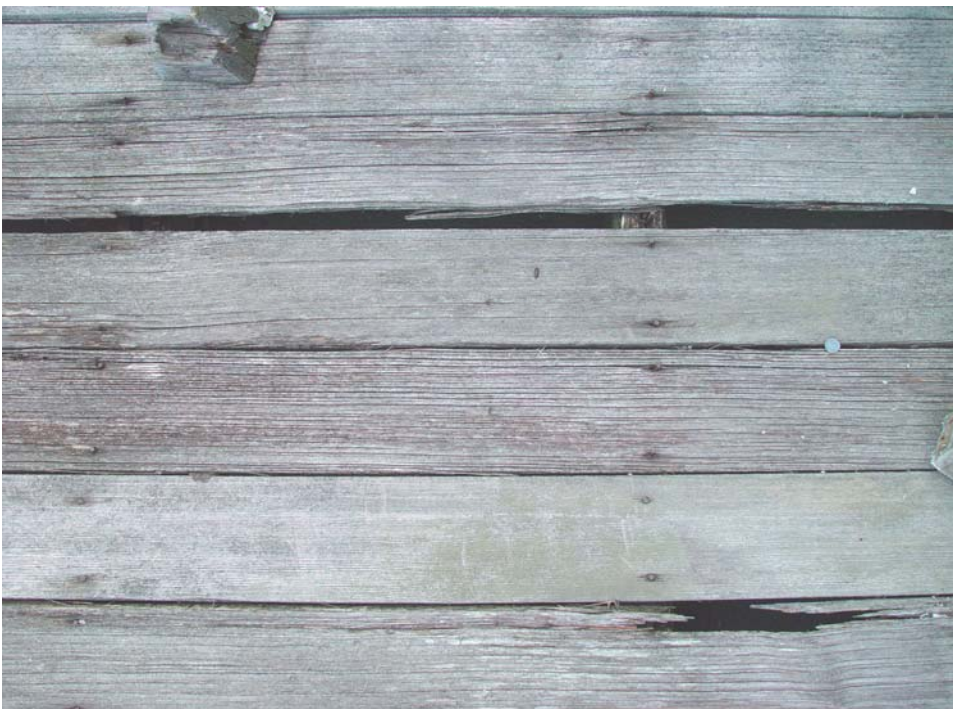
Fig. 69
Heavily deteriorated west balcony floor decking and sleepers beneath.

***R3.8-6** Document and carefully remove decking, balustrade, and awning frame from west balcony. Replace roll roofing with new to match existing, complete with bituminous polyethylene underlayment and lead coated copper flashings. Install new balcony sleepers and decking matching original configurations. Reproduce deteriorated balustrade and awning frame elements. Preservative treat and prime all reproduction and remaining original wood balustrade and awning frame elements, and reinstall. Paint completed work with selected trim color. (\$7,600)*

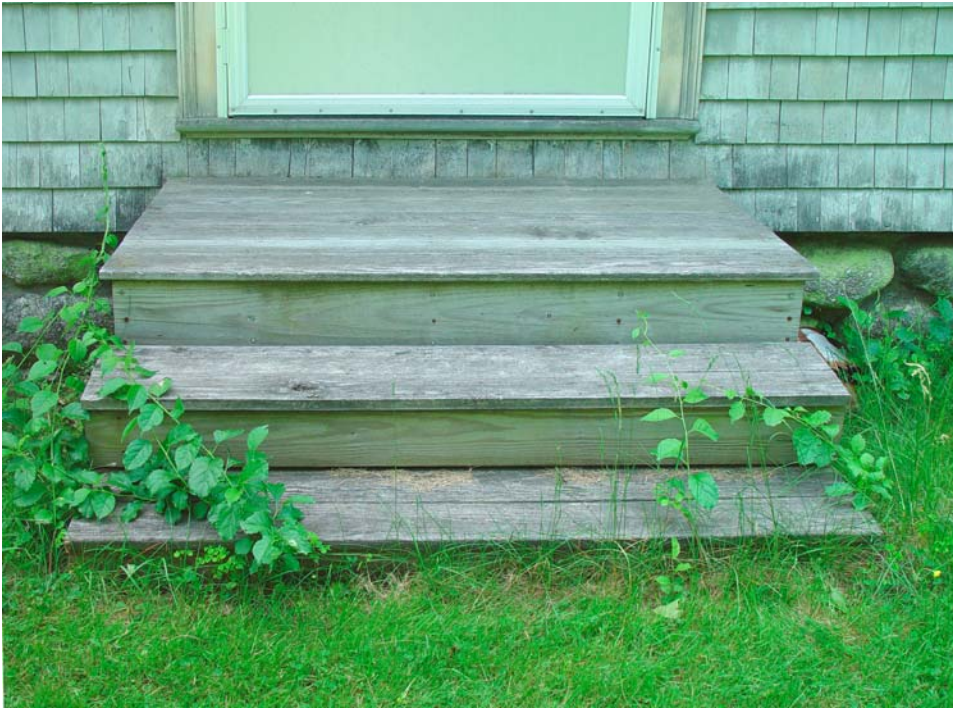
Fig. 72
Modern stair at easterly door on north elevation is in marginal condition.

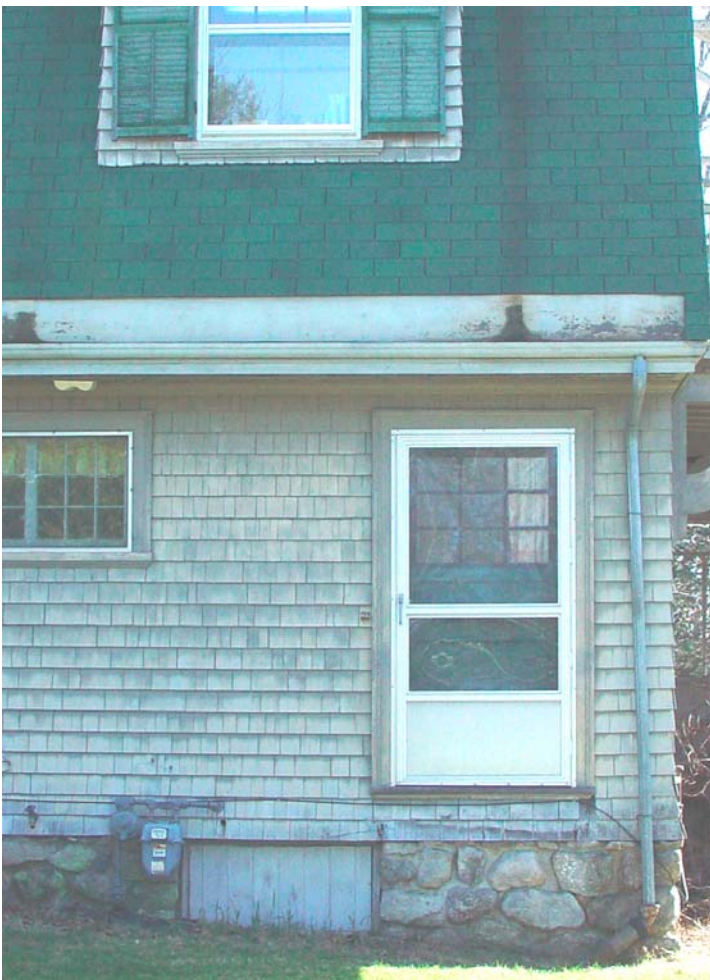
Fig. 73
Missing stair at westerly door on north elevation should be reinstated.

***R3.9-2** Replace missing stair formerly serving the north elevation west wing doorway with new code-compliant stair, detailed to be visually compatible with the historic setting. (\$2,700)*

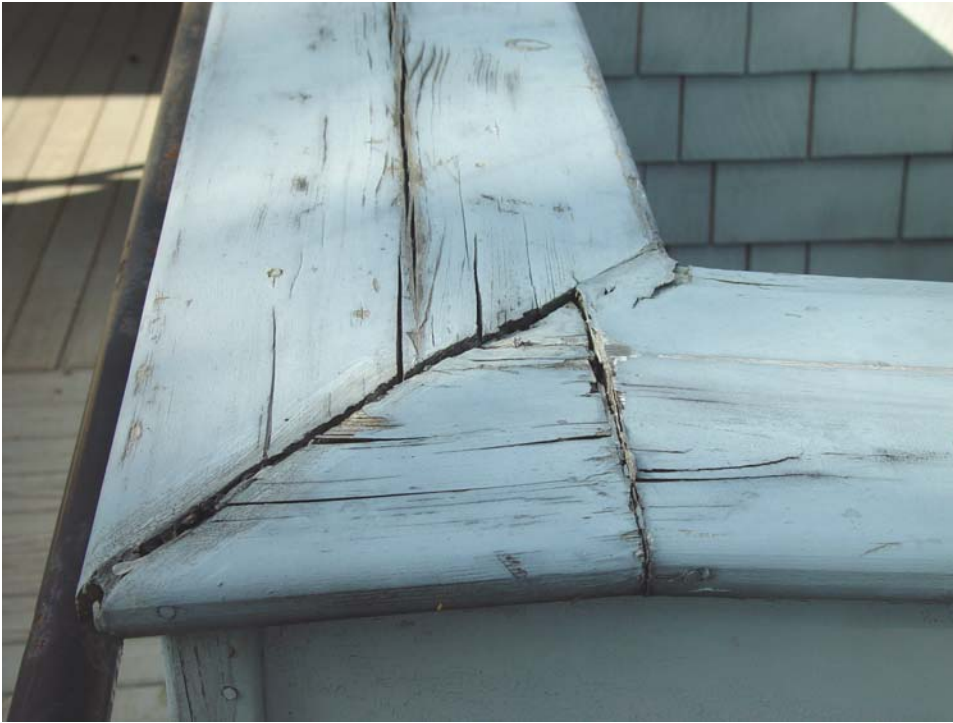
Fig. 74
Opening of miters and cross-joints, and severe checking have developed in the new wheelchair ramp parapet caps.

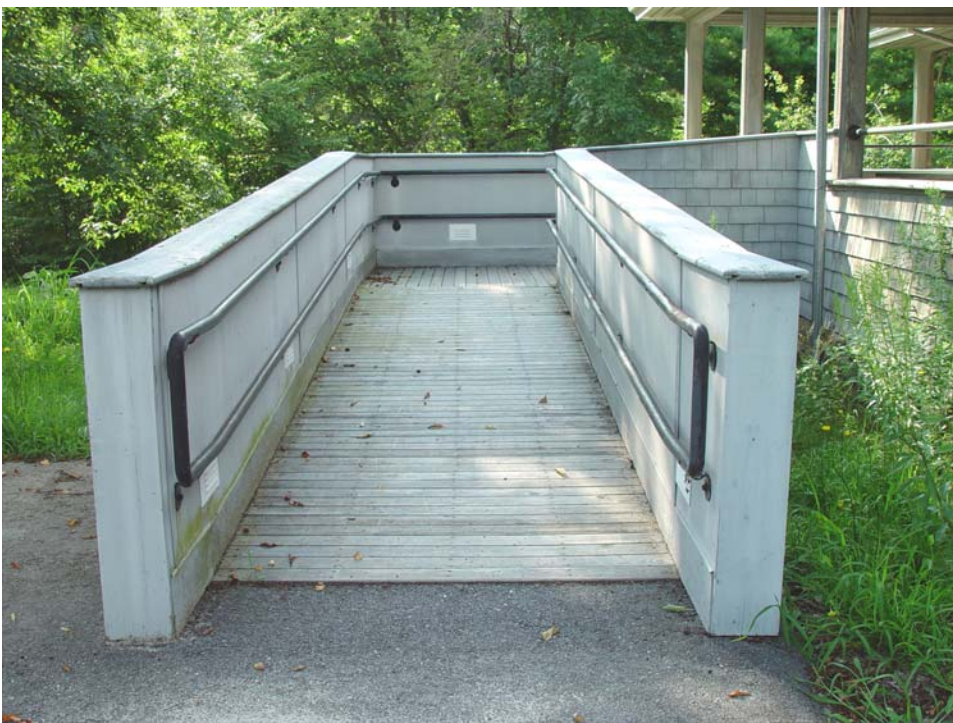
Fig. 75
MDO plywood cladding interior sides of ramp parapets are damp and supporting heavy algae growths.

***R3.9-4** Remove deteriorated ramp baluster caps, and alter ramp wall height to match elevation of veranda walls. Install wood shingle cladding in lieu of MDO plywood on interior faces of ramp walls. Install new plank caps with reconfigured profile and butt joints, and new bed moldings beneath. Install new pipe rail guards at same elevation as veranda guards. Pre-treat all new wood elements with borate solution and full priming. Caulk and paint all trim elements with at least two coats of selected trim paint, and apply at least two coats of stain to all shingles. (\$8,900)*

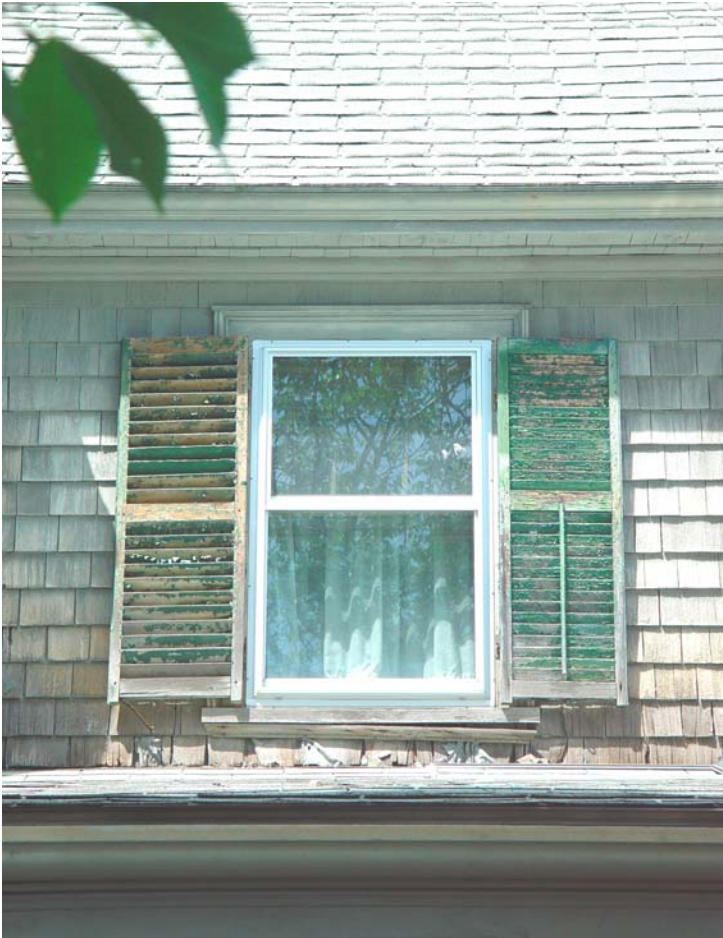
Fig. 76
Minor checking and decay
developing in upper story
windowsills. Also note open
joint of bed molding.

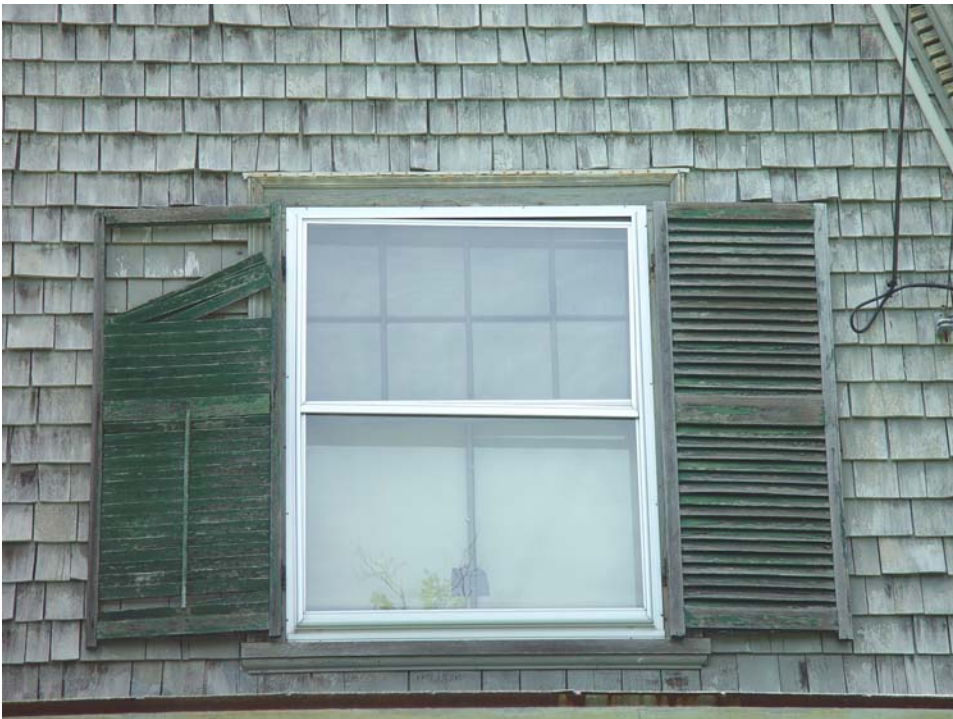
Fig. 77
Exterior blinds are generally in poor condition except where protected
beneath veranda roofs.

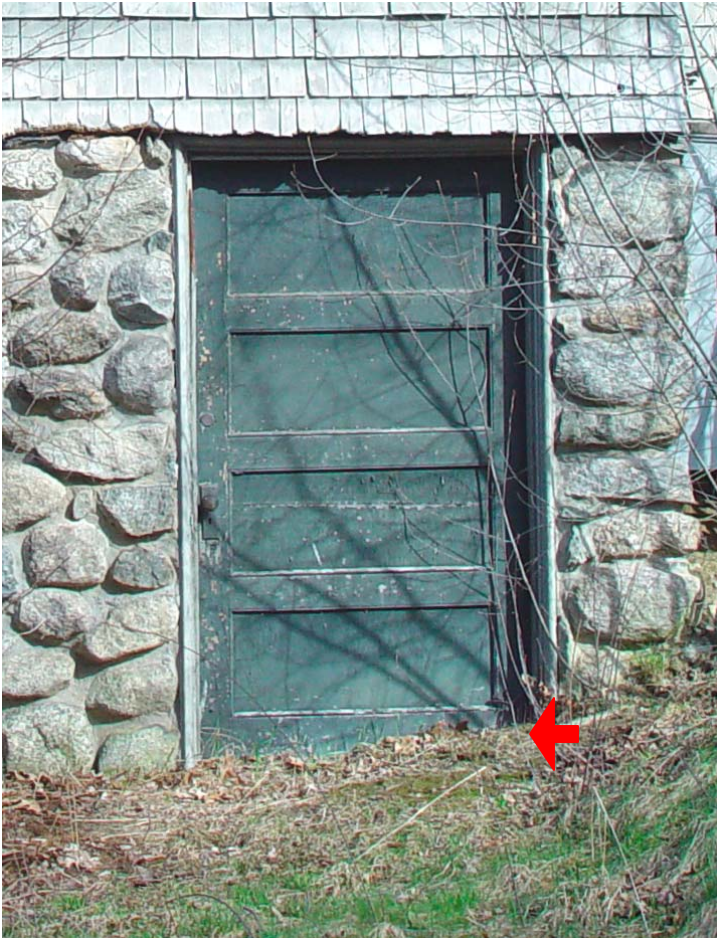
Fig. 78
Lower rails and stiles of west
cellar door are deteriorated
from ground contact.

R3.10-7 Remove existing west elevation cellar door and execute epoxy or pieced-in repairs as required. Prime and paint with selected door leaf color prior to reinstalling. Also execute epoxy or pieced-in repairs to lower frames and sill. Prime and paint selected trim color. (\$1,650)

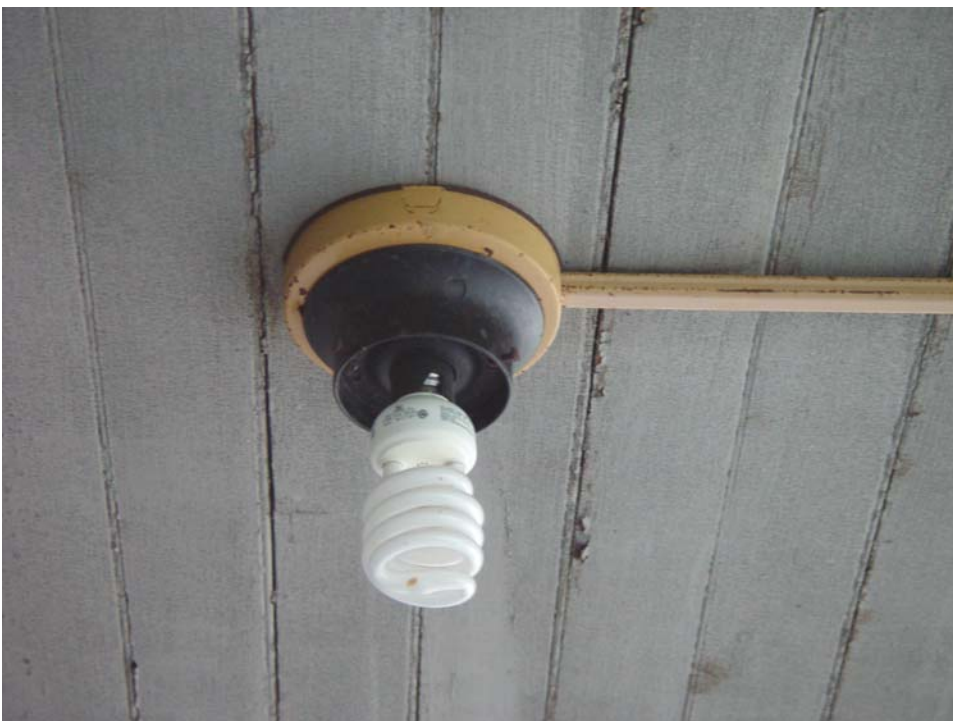
Fig. 81

Veranda ceiling fixtures rewired with inappropriate surface-run raceways and relamped with fluorescent bulbs.

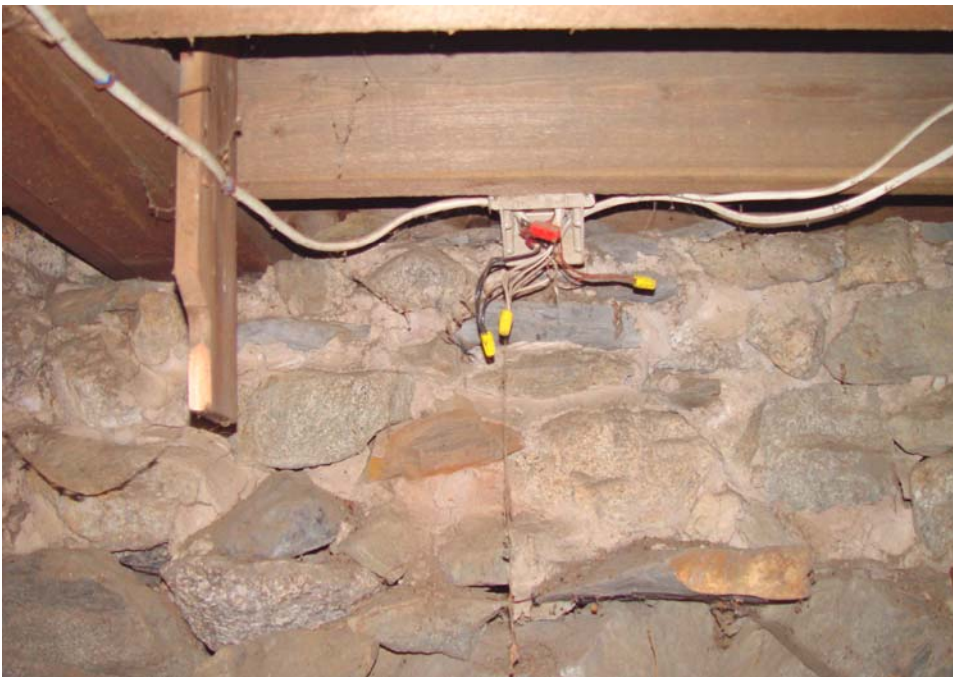
Fig. 83
Junction box beneath south veranda with protruding conductor splices and
missing cover.

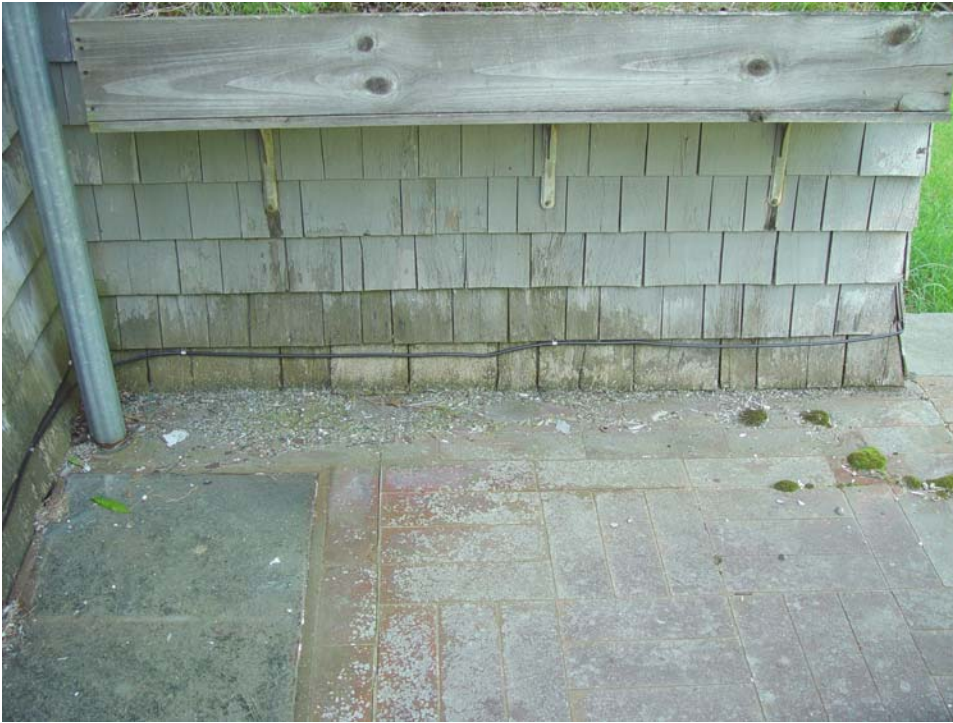
Fig. 86
Cable television branch conductors traverse exterior wall surfaces to reach their destinations.

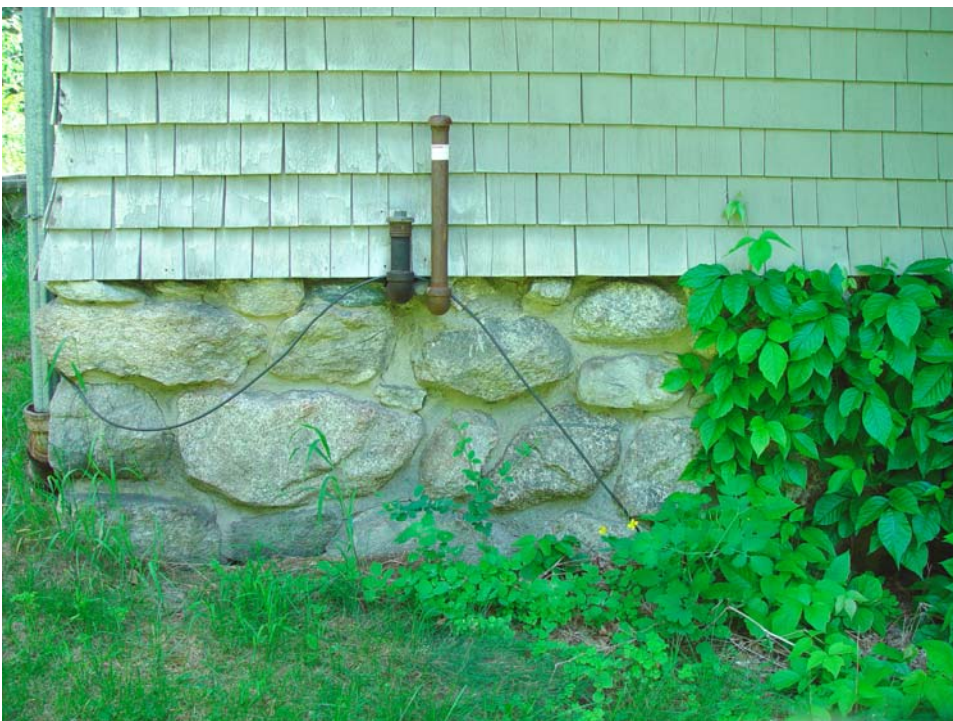
Fig. 87
Poorly secured cable television branch conductors draped over the oil fill and vent pipes.
