This draft report provides a summary of the 2013 in-lake water quality sampling and the in-lake plant, shoreline iris and downstream wetland plant surveys. I am still awaiting laboratory results from the August 29th sampling. I will update this report when those data are received.

In-Lake Sampling

In-lake Plant Survey

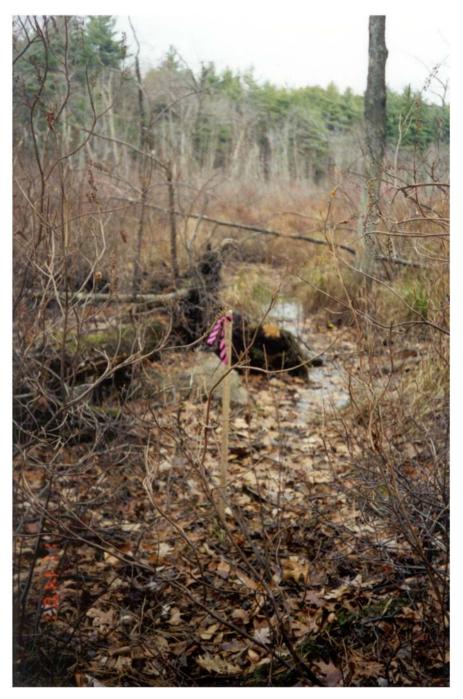
Figure 7. Vegetation sample plot No. 1 in the scrub *I* shrub emergent wetland below the dam, sampled on November 14, 2001.

Vegetation sample plot is located in the scrub-shrub wetland community approximately 100 ft. north of the dam at the northern end of the pond. Access to the sample plot is from the service road to the dam off Willow Road. A narrow fringe of flood plain forest occurs along the edge of the sample plot. The estimated plant cover in the sample plot is over 60 percent. The sample plot was photographed during the survey performed on November 14, 2001.

Sample plot is subject to spring floods and backwater flooding due to a beaver dam at the culvert under Route 110. Dam material was recently removed from the culvert. Standing deadwood is present in the scrub-shrub wetland due to past flooding. A windfall red maple occurs in the sample plot. Soil consists of approximately 3 inches of black muck over sands and gravel. Soil was saturated with free water recorded 8 inches below the soil surface. Signs of past flooding were evident at the base of standing trees and exposed boulders.

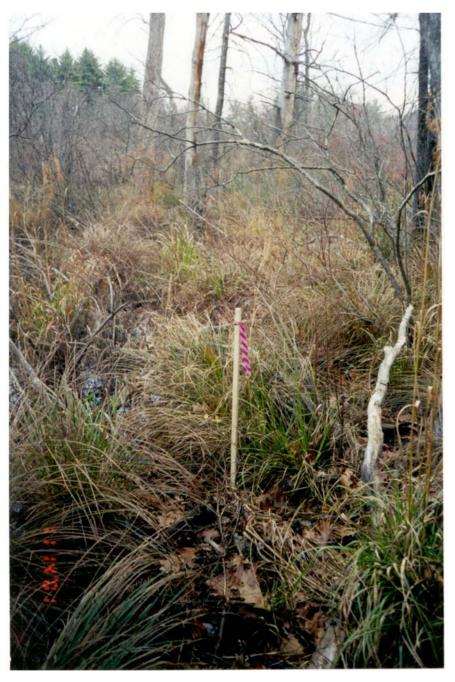
Figure 8. Vegetation sample plot No. 2 in the scrub *I* shrub emergent wetland below the dam, sampled on November 14, 2001.

Vegetation sample plot is located in the scrub-shrub wetland community approximately 500 ft. north of the dam at the northern end of the pond. Access to the sample plot is from the service road to the dam off Willow Road. A narrow fringe of flood plain forest occurs along the edge of the sample plot. The estimated plant cover in the sample plot is over 60 percent. The sample plot was photographed during the survey performed on November 14, 2001.

Sample plot is subject to spring floods and backwater flooding due to a beaver dam at the culvert under Route 110. Standing deadwood is present in the scrub-shrub wetland due to past flooding. Soil consists of approximately 8 inches of black muck over sands and gravel. Soil was saturated with free water recorded 2 inches below the soil surface.
