Bare Hill Pond Watershed Management Committee
Town of Harvard
Harvard, MA 01451

Re: 2015-16 Drawdown Report and Fall 2016 Drawdown Plans

Bare Hill Pond In-Lake Water Quality, Plant Survey and Wetland Plot Monitoring 2016

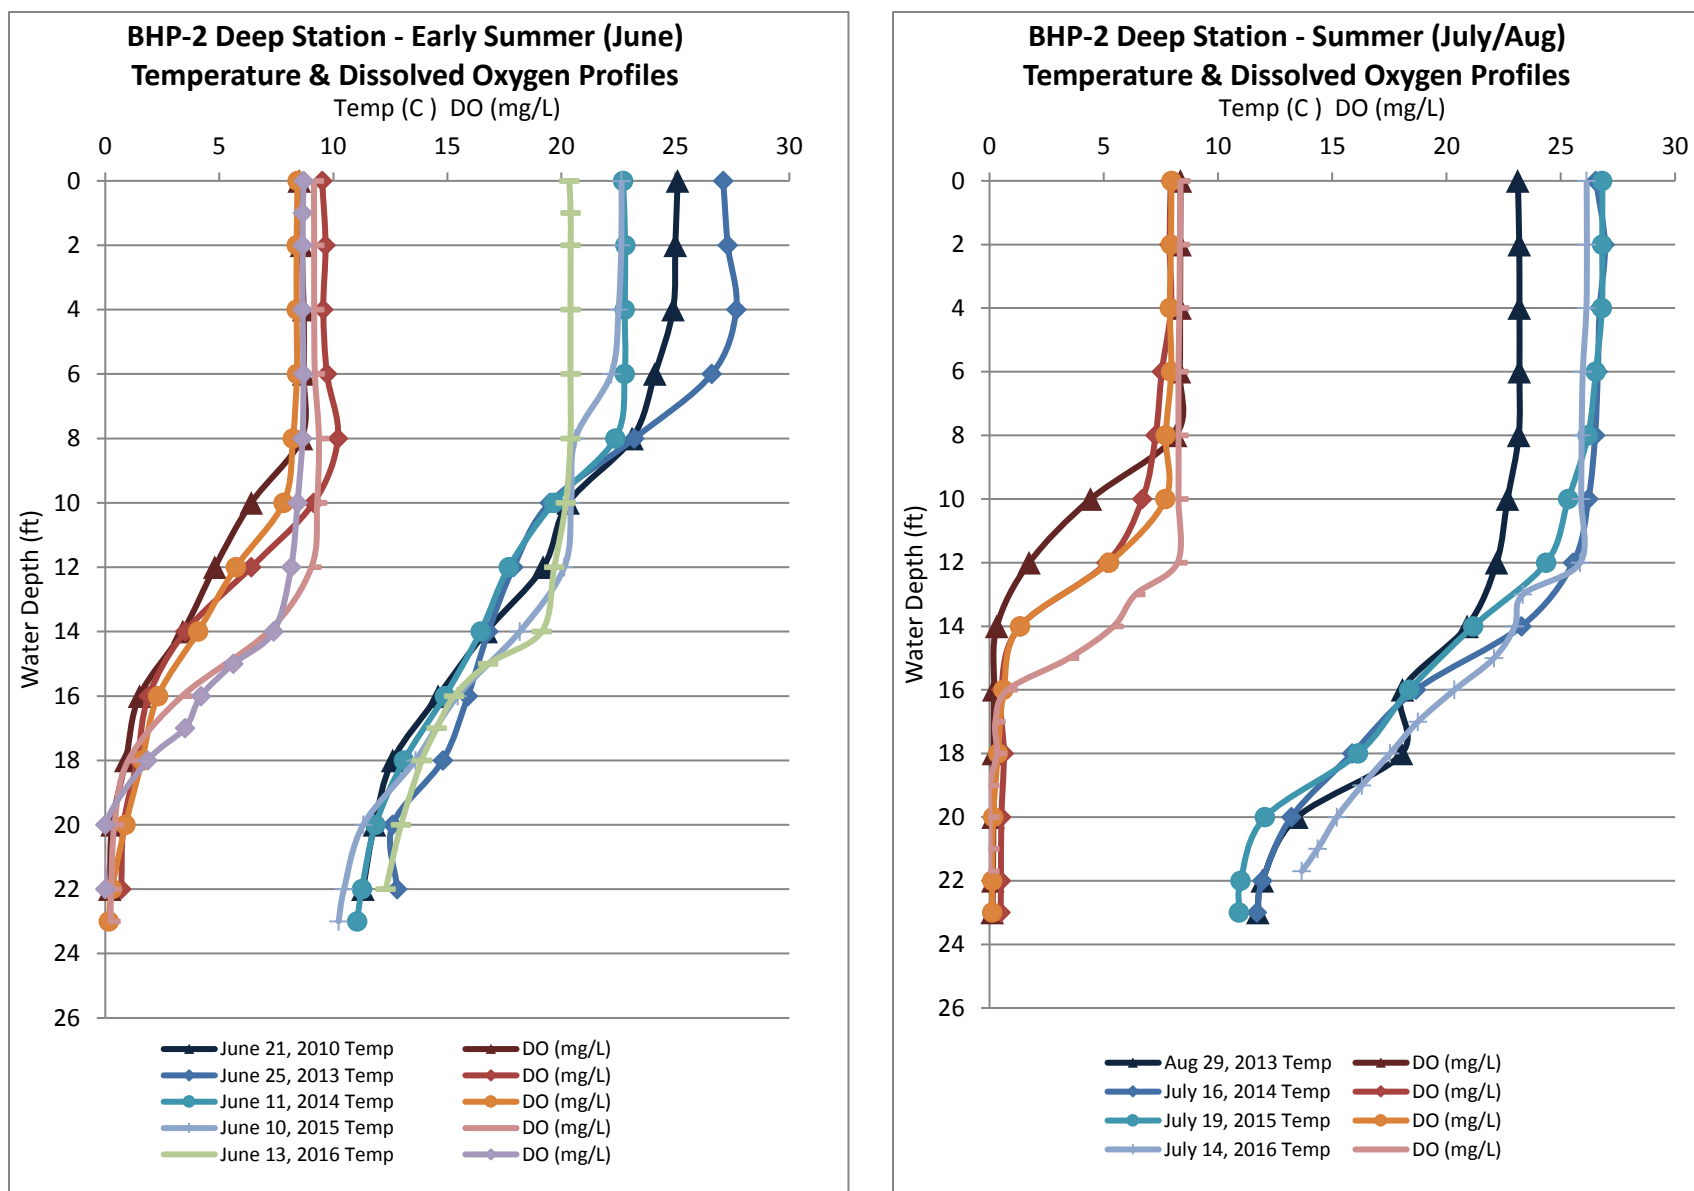
Figure 1. Temperature & Dissolved Oxygen Profiles at BHP-2 for 2010-2016

The temperature and DO profiles suggest that the lake began to thermally stratify in May and was weakly stratified by July. Concentrations of DO in May were consistent throughout the water column until a depth of eight feet and showed a slow decline with increased depth. DO dropped substantially after 12 feet in June and July. Concentrations were below the desirable level for fish [5 - 6 milligrams-per-liter (mg/L)] at and below 14-16 feet. These data are consistent over the last several years (Figure 1).

Oxygen depletion starts above the thermocline. Much of the cold water fish refuge area is undesirable given the lack of oxygen. These data suggest that the lake has a substantial oxygen demand and is susceptible to iron-bound phosphorus release from the sediment. Phosphorus can accumulate in the hypolimnion under these conditions. Once the hypolimnetic phosphorus is mixed in the photic zone, algal blooms are more likely to occur.

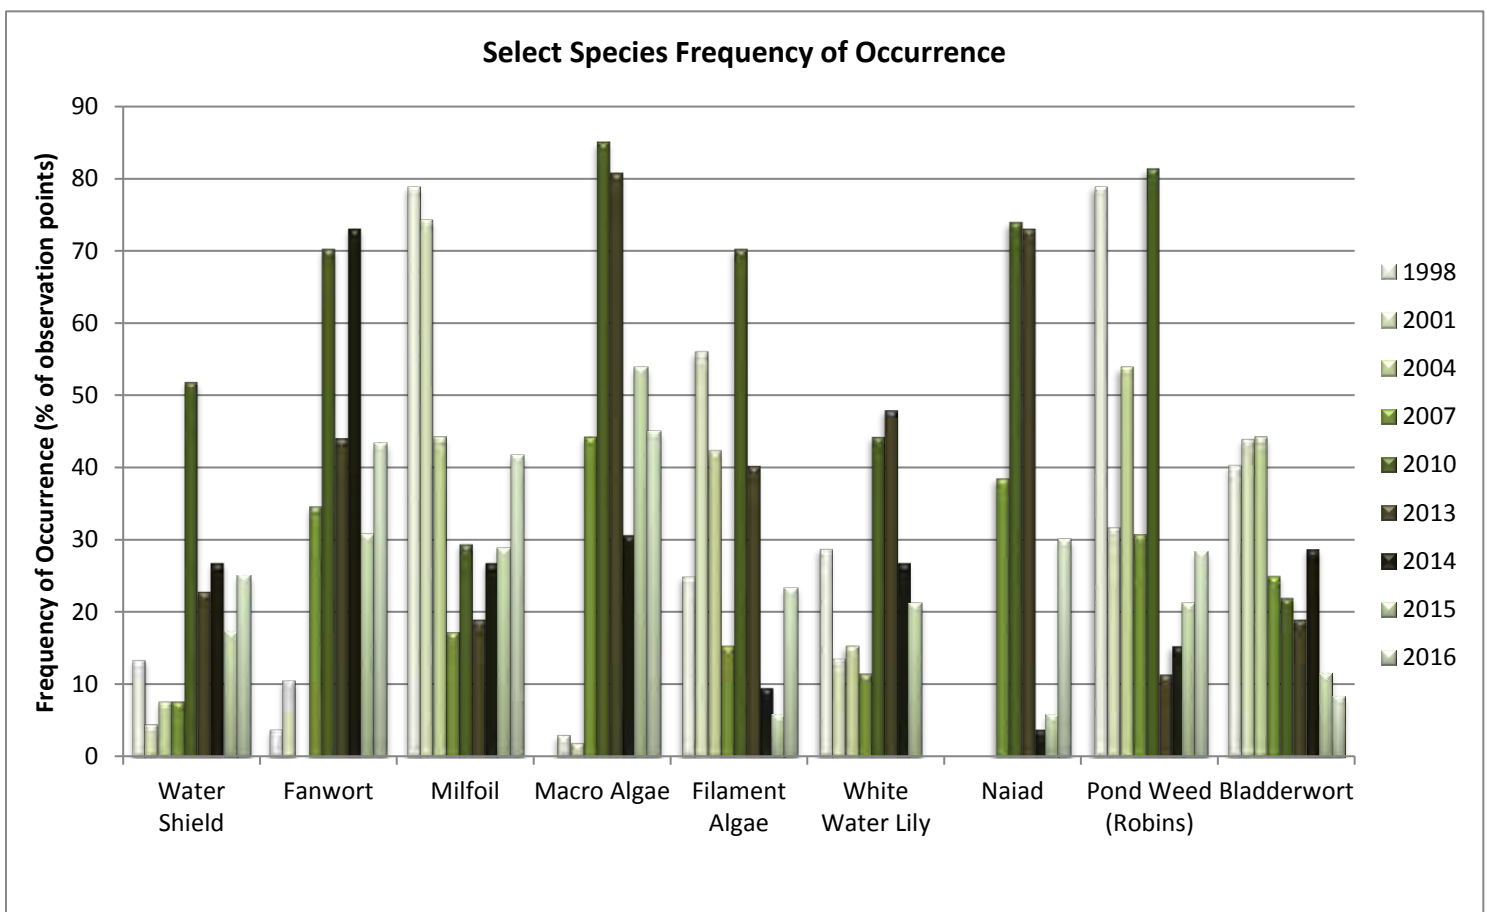
Figure 6. Bare Hill Pond Select Plant Species Frequency of Occurrence

The general appearance of the pond showed substantially more plant growth topping out at the surface in 2016 than in 2015. This observation is supported by the frequency data and general observations outside the survey points. Watershield, fanwort, milfoil (*Myriophyllum heterophyllum*) and pondweeds (*Potamogeton* spp.) were encountered more frequently at sampling locations in 2016. Figure 6 illustrates the most frequently encountered species data since 2010. Macro algae were abundant again in 2016 (observed at just under 50% of the points). This non-vascular plant is low growing and forms a carpet on the bottom. Plant dominance has shifted from fanwort and milfoil to macro algae and naiads (*Najas* spp.) in past drawdown years. The native plant tape grass (*Vallisneria americana*) was more frequent this year than in years past (10% increase). This plant is an excellent source of food for waterfowl. While these species shifts may not result in a decrease in plant cover, it can reduce plant biovolume if widespread and represent a desired outcome provided plant diversity is maintained or improved.

2016 data and general observations suggest that milfoil and fanwort density have increased, with milfoil making a resurgence from lower frequencies over the past six years. Thick patches of milfoil were observed when traveling to and from the sample locations. Plants in water depths up to 8-10 feet were observed topping out at the surface. Native pondweeds were also very abundant at and between observation locations.
