CONDITION ASSESSMENT AND RECOMMENDATIONS

Preservation of the Hildreth House

Harvard, Massachusetts

**FINAL DRAFT
October 11, 2004**

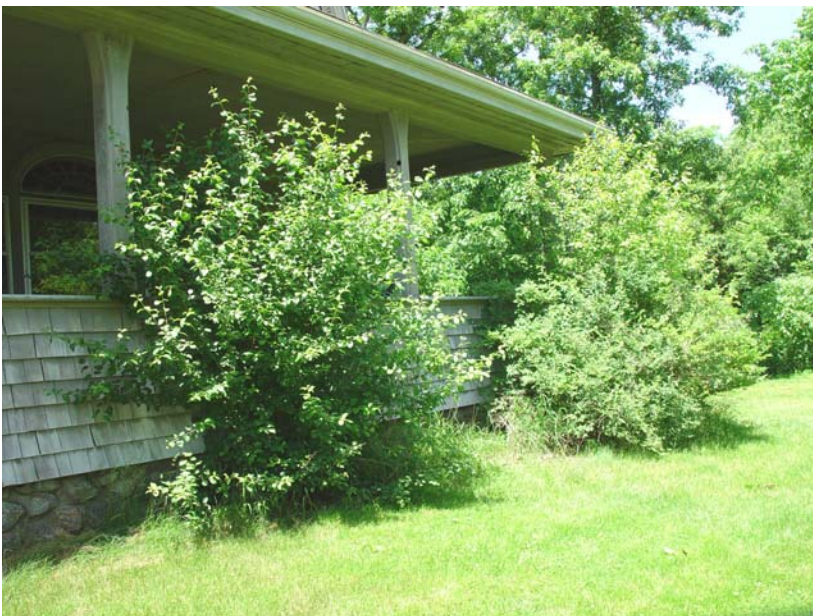
tend to be perennial groundcovers such as hosta. Closely planted shrubs at two locations along the east veranda are beginning to overwhelm the shingled parapet, trapping moisture within the wood materials adjacent (Fig. 6).

Fig. 6
Closely planted shrubs
along the east veranda in
need of pruning.

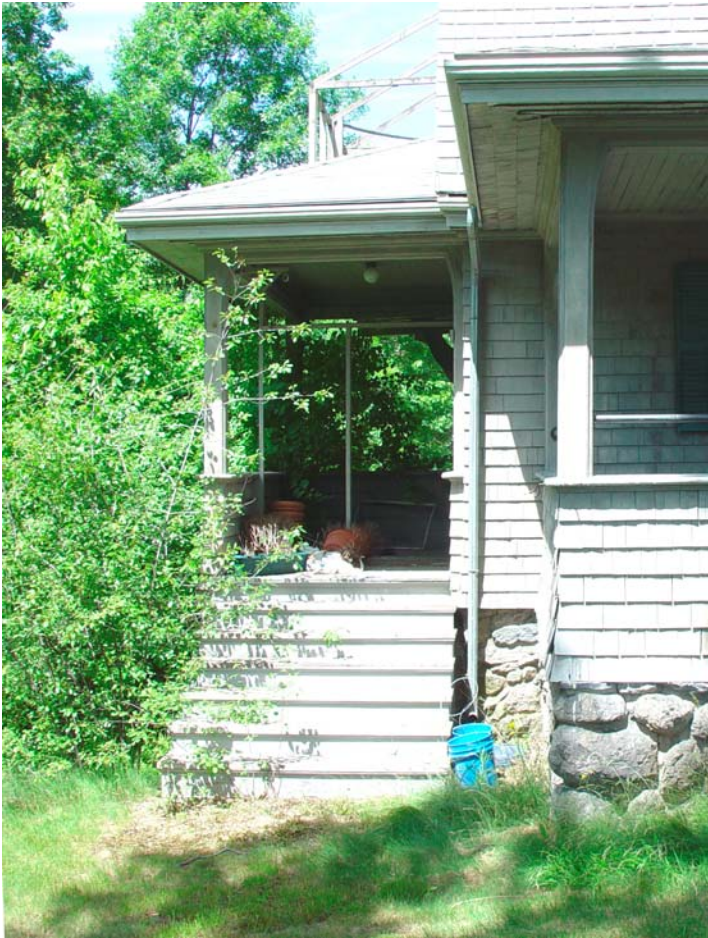
More problematic however are numerous volunteer shrubs, vines, and young trees subsuming nearly the entire breadth of the west elevation, and particularly the west veranda (Fig. 7). Apart from rendering maintenance access impossible, these impede light and air from drying adjacent wood and masonry materials alike, and foster establishment of mildews and lichens. This elevation is particularly vulnerable due to the close proximity of forestation on the west, which already limits the amount of sunlight that would normally be available. Moreover, several of the encroaching volunteers are of a size to promote clogging of gutters and conductors with fallen leaves, and to provide penetration of shingle and trim joints with vine tendrils. Unchecked growth on this side of the house has rendered mowing impossible, which in turn has enabled proliferation of poison ivy throughout the area.

Fig. 7
Volunteer trees, shrubs, and vines
overwhelming the west veranda.

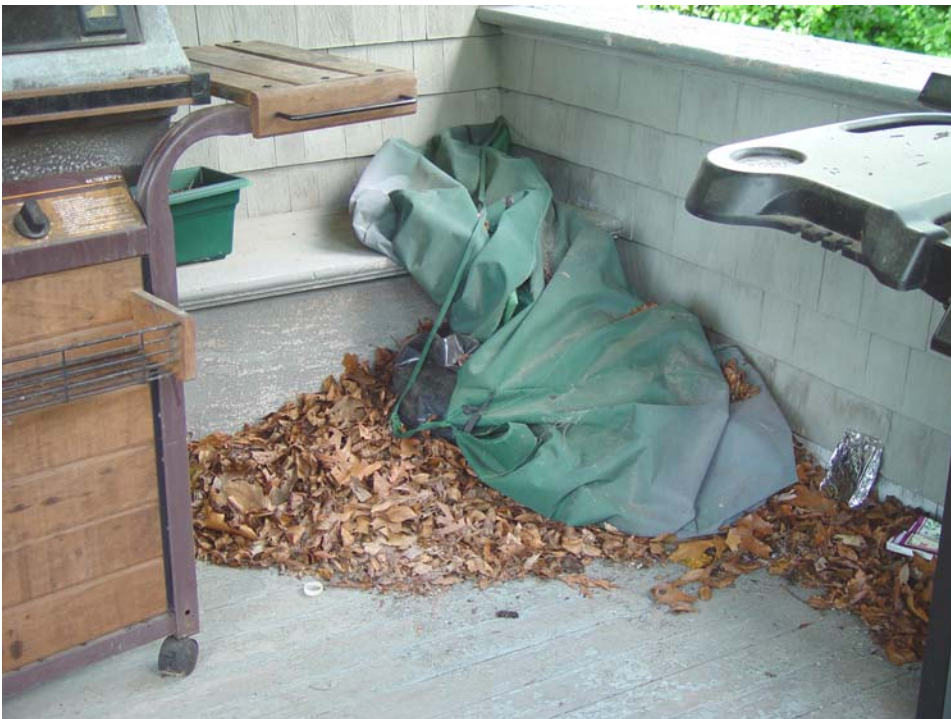
Leaves and remnants of vegetation tend to accumulate in corners of the verandas, either because they have not been regularly swept out (as at the north end of the east veranda) (Fig. 8), or because abandoned planter pots and boxes tend to entrap them (as on the west veranda) (Fig. 9). These in turn hold moisture against vulnerable wood surfaces, and provide nesting for vermin.

Fig. 8
Leaves accumulating in the corner of the east veranda.

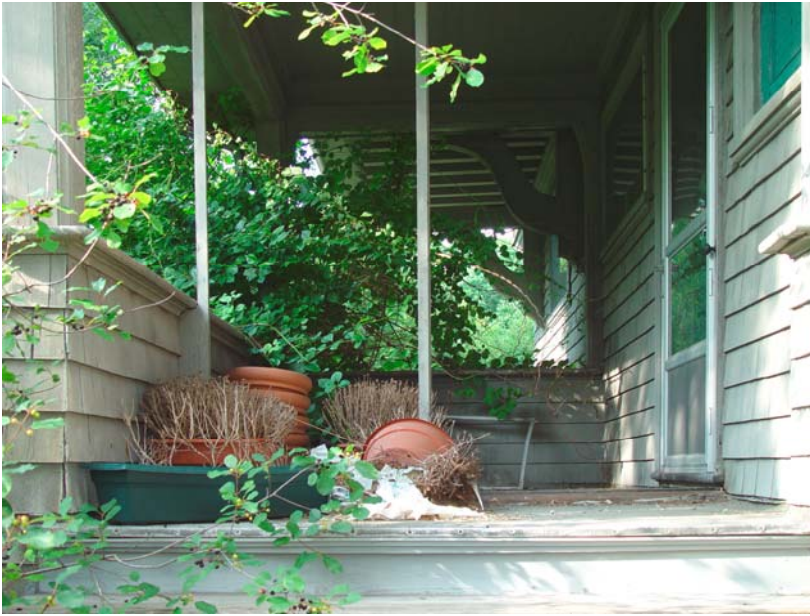
Fig. 9
Abandoned planter pots
and boxes on the west
veranda.

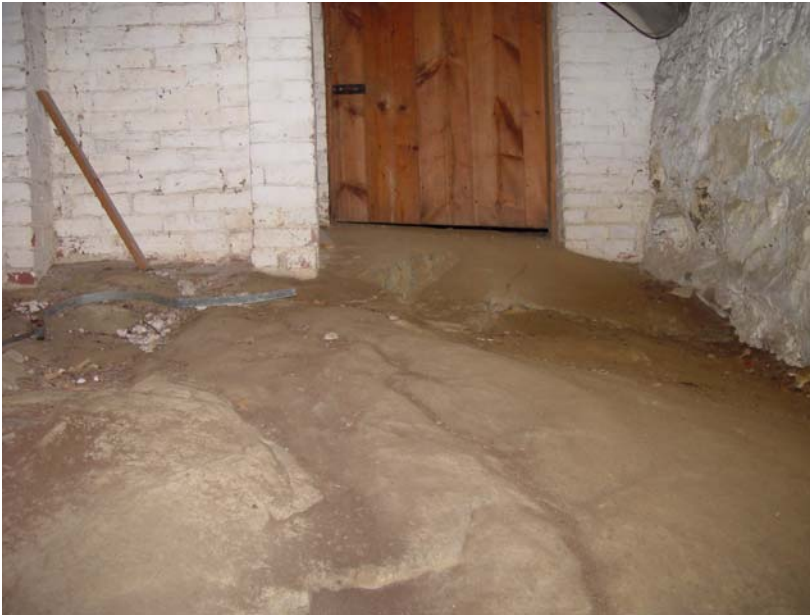
Fig.10
Exposed ledge in the
easterly portion of the
cellar, with crawlspace
access beyond.

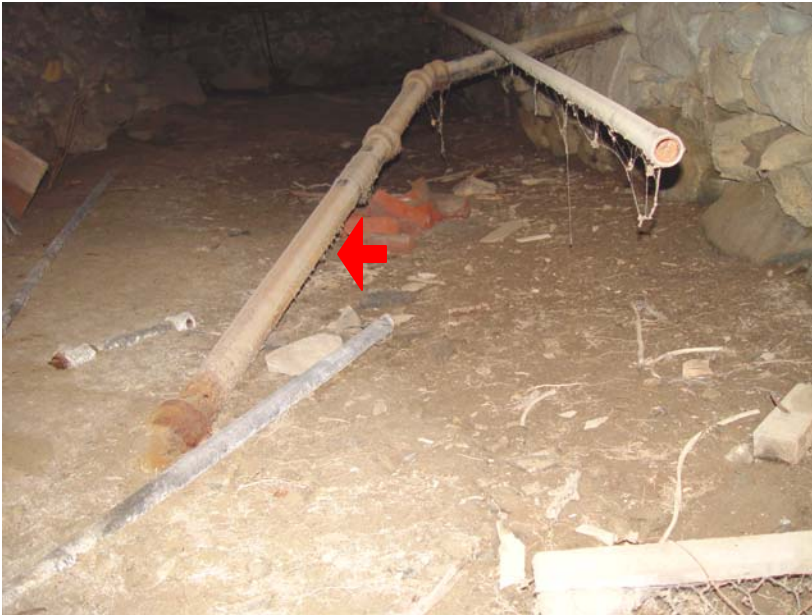
Storm and roof drains were often routed through buildings to lessen the problems of freezing and to access the sanitary sewer system from within. Although once commonplace, combining storm and sanitary drainage is no longer an accepted practice. Apart from overburdening the sanitary system, conductor drains running through the Hildreth House cellar greatly increase the potential for inadvertent discharge of water along interior locations en route. For example, the wye fitting in the cellar joining the two drains penetrating the north terrace has an open leg through which substantial quantities of water could escape if a clog developed downstream (Fig. 24). The condition of the conductor drains that have already been abandoned suggests that leakage into the building was already a chronic problem (Fig. 25).

Fig. 25
Abandoned conductor
drain in crawlspace of
south veranda.

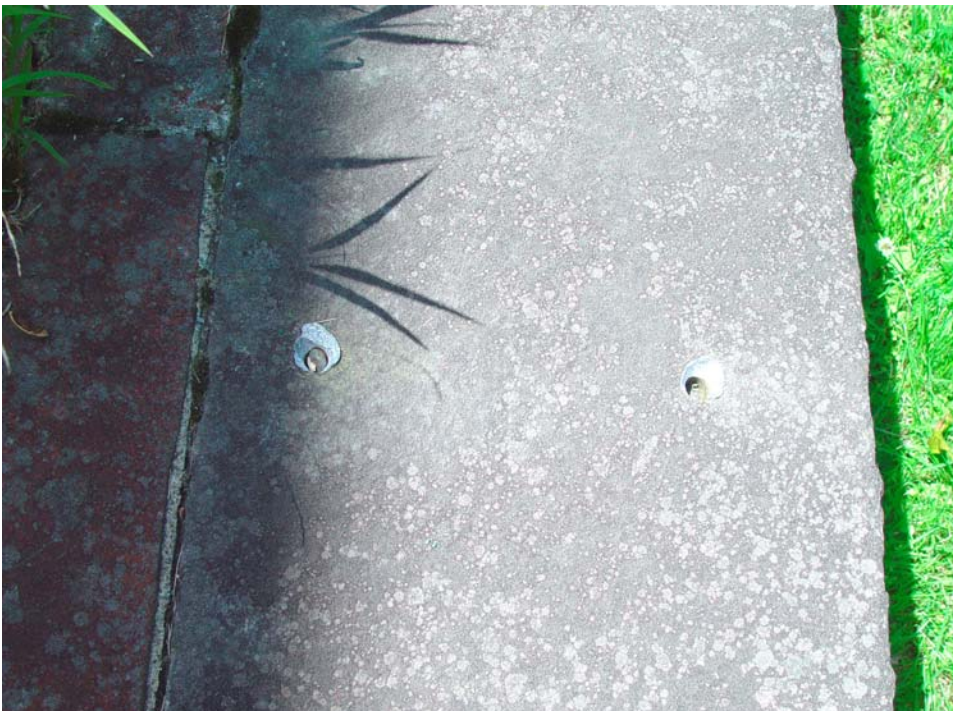
Fig. 33
Remnants of iron pins formerly securing the north terrace balustrade.

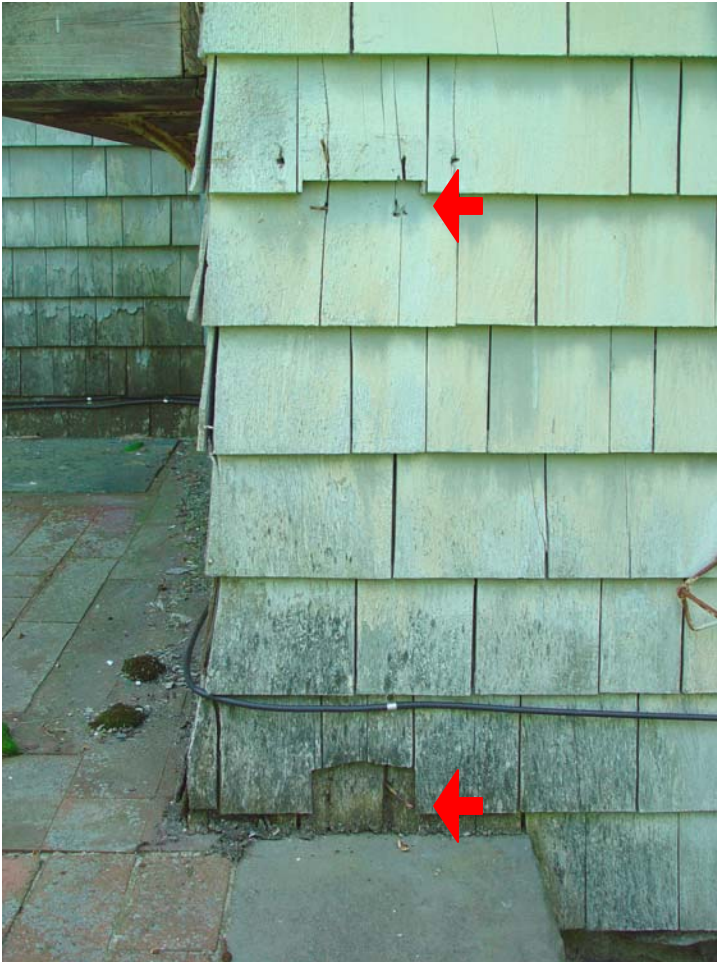
A raised brick paved terrace tucked between the two projecting wings of the north elevation appears to be an original feature of the house. The pavement, of face bedded 11½-inch by 3¾-inch Roman brick laid in a basket weave pattern, is supported on a fieldstone platform constructed in the manner of the foundation walls. A flush-set sandstone coping borders the brick pavement along the terrace's exposed faces. The terrace engages the building walls just below the apron of the dining room north door, and provides access to grade via a short stair descending easterly off the northeast corner, which consists of one intermediate tread of the same coping stone. Along the north exterior wall of the dining room, heavy glass lights, set flush with the pavement in tripartite frames, cover three cellar window areaways. Remnants of iron pins in the coping betray the prior existence of a wooden perimeter balustrade (Fig. 33). The profile of the balustrade remains apparent in the shingling at the northeast corner of the north elevation's west wing (Fig. 34).

Fig. 34
Evidence of former north terrace
balustrade engaging the shingled
wall.

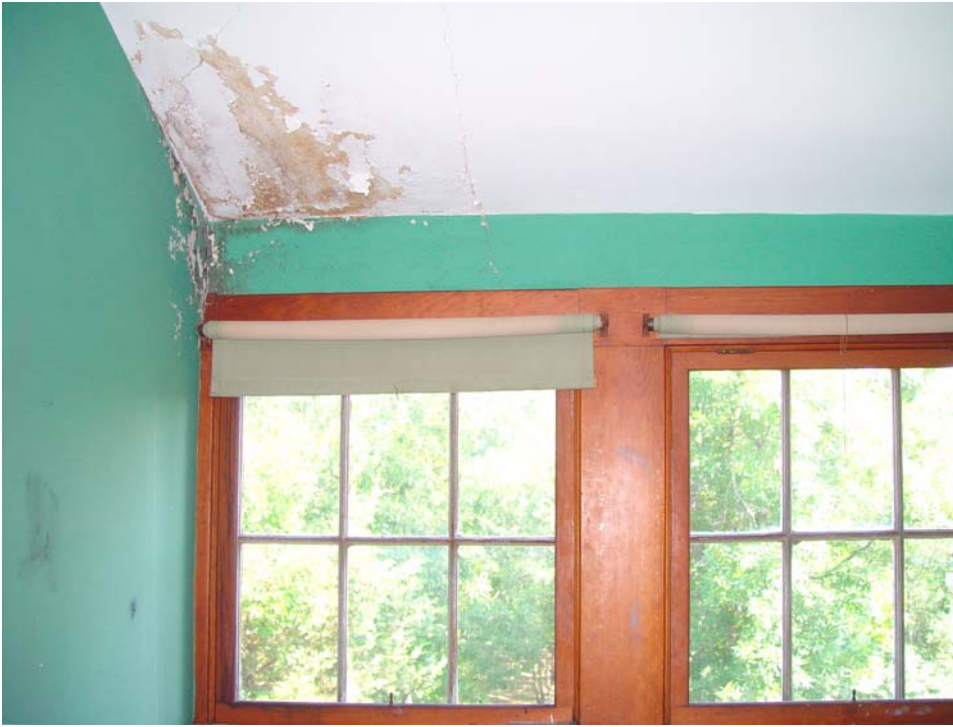
Of the three campaigns, the most recent (the north elevation) appears to have been conducted in response to some rather egregious conditions in the attic finishes; where numerous water stains had appeared around the central shed dormer (Fig. 40), and ceiling plaster had been lost below the upper end of the dormer's east cheek wall. At least two ventilating roof scuttles (the structural framing of which remains above the present easterly dormer) have been abandoned and roofed over (Fig. 41). The roof remains in relatively good condition, and does not appear in need of replacement (Fig. 41).

Fig. 40
North dormer plaster damage leading to recent replacement of northerly slope of main roof.

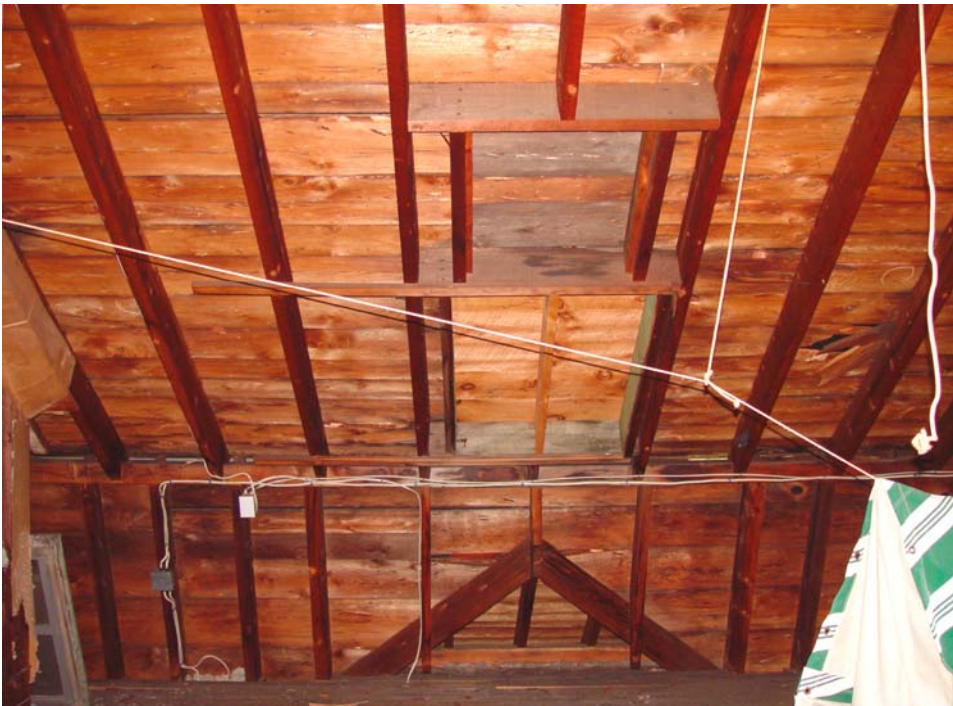
Fig. 41
Framing for abandoned ventilating scuttle on north slope of main roof.

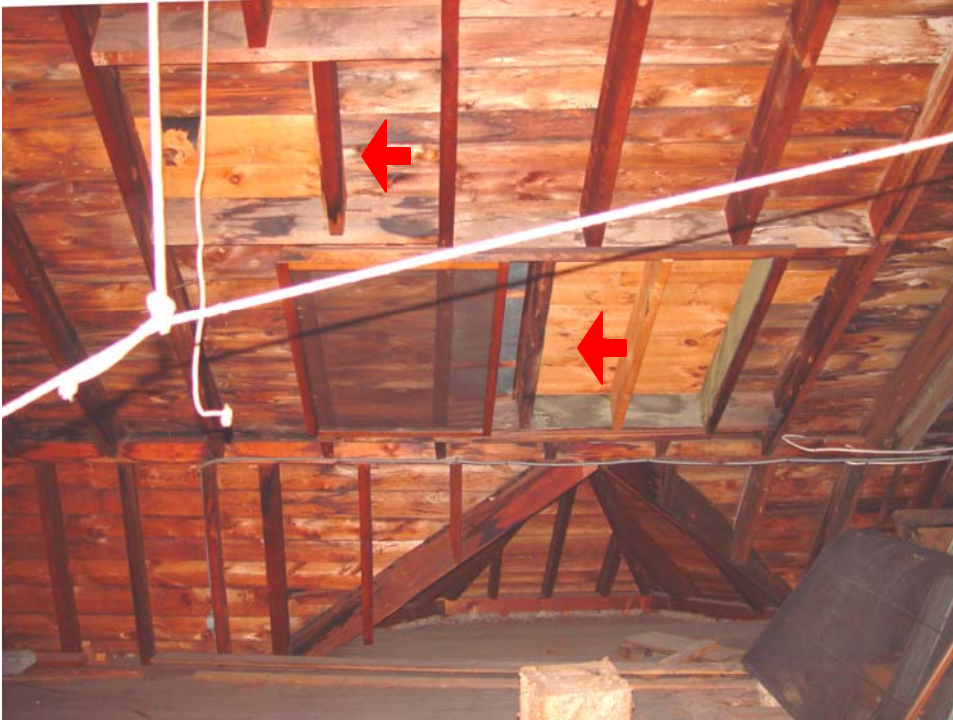
Fig. 44
Framing for abandoned ventilating scuttles on south slope of main roof.

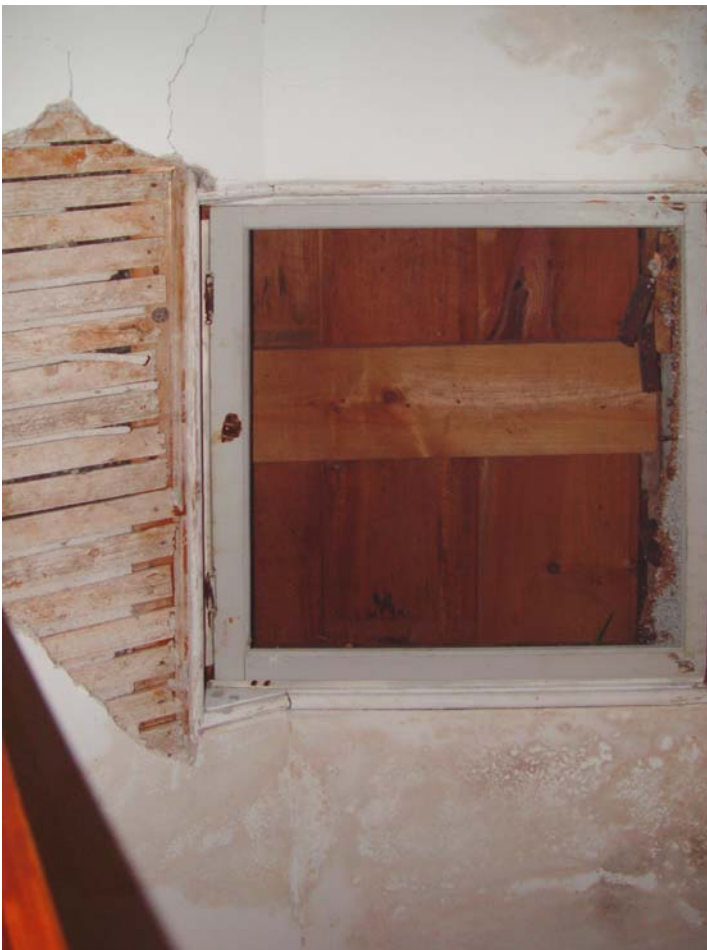
Fig. 45
Plaster loss adjacent to frame of
abandoned center scuttle.

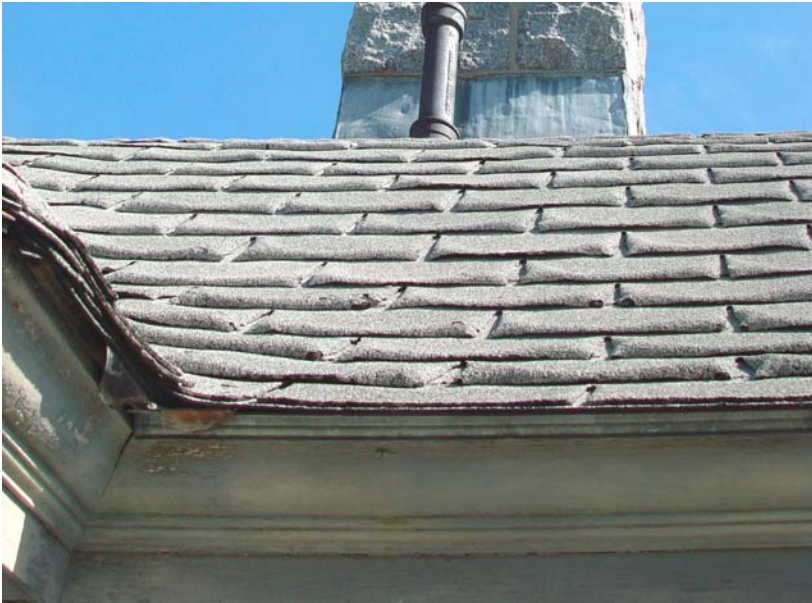
Fig. 46
Curling of shingles on
south slope of main roof.

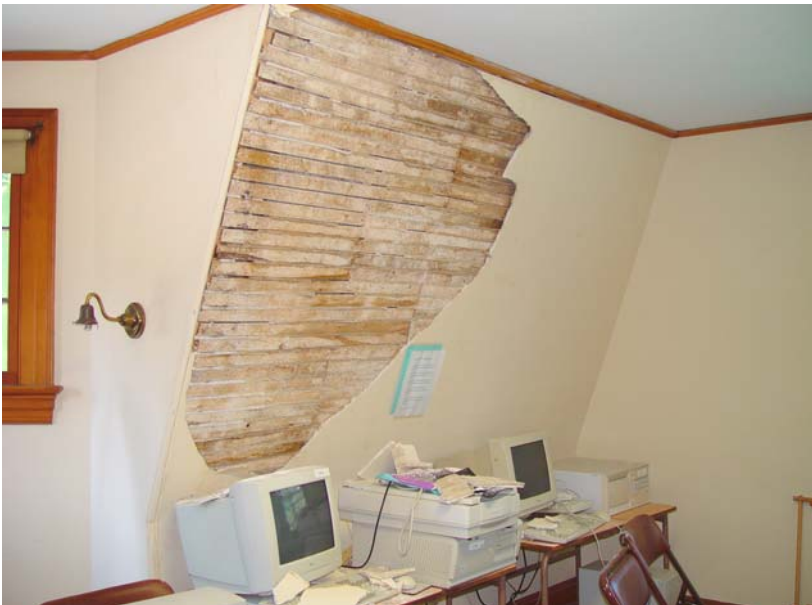
Fig. 47
Recent plaster loss from
southwest chamber.

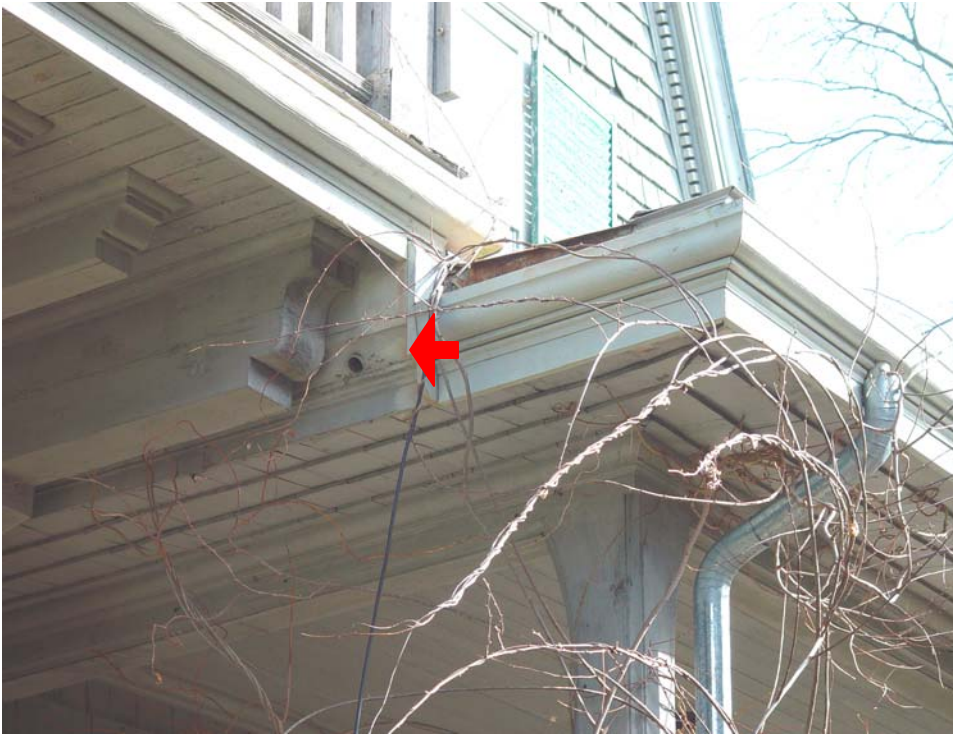
Fig. 49
Remnant of original gutter on north eave of west veranda.

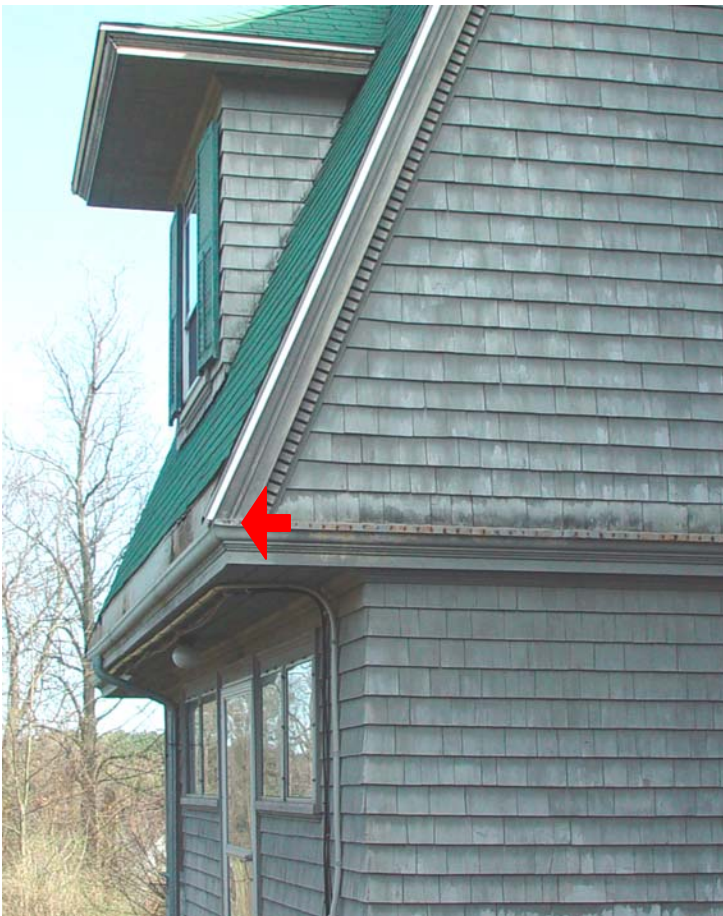
Fig. 50
Juncture of original belt and
rake profiles with modern
incompatible gutter profile.

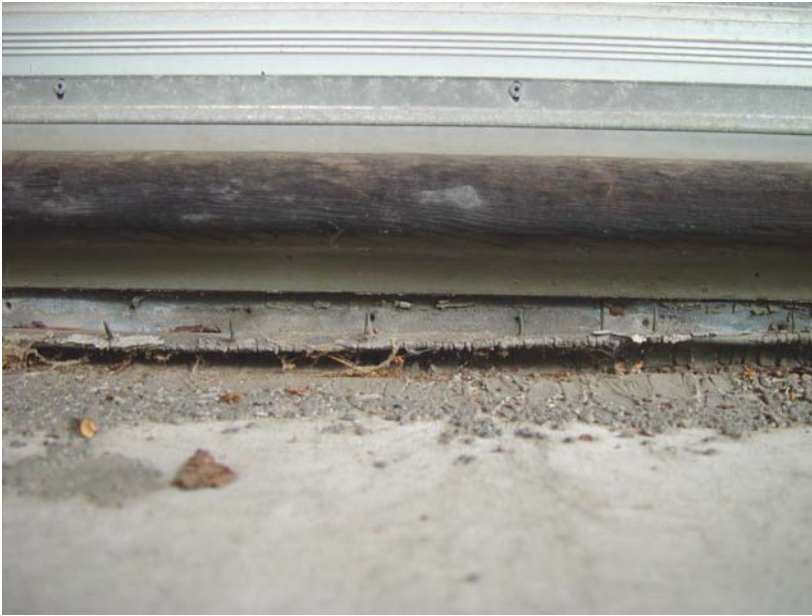
Fig. 65
Zinc flashing beneath the
threshold of the west
veranda service door
engages the canvas floor
cladding.

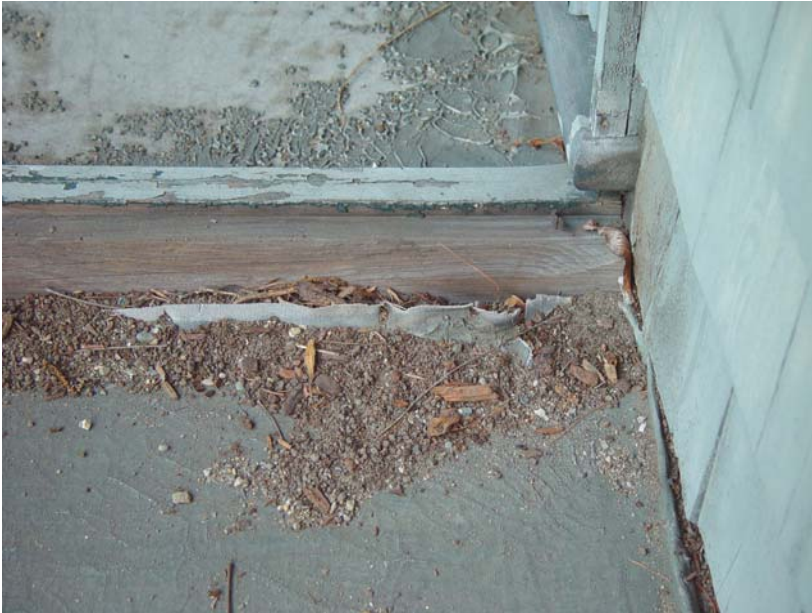
Fig. 66
Sill for screen panel
crossing the canvassed
west veranda floor.

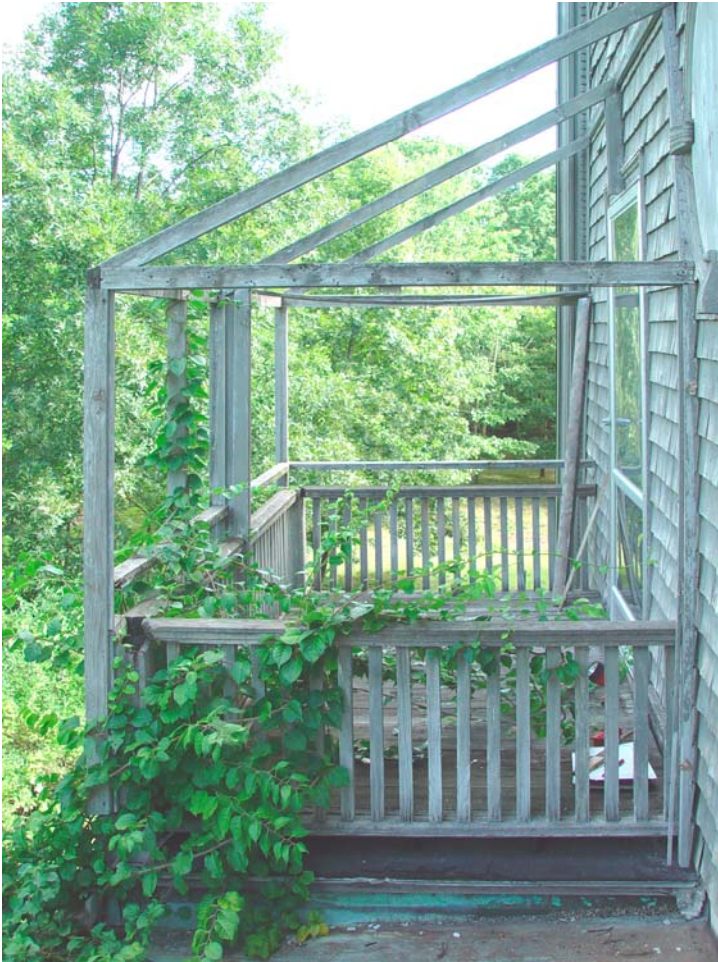
Fig. 68
West balcony balustrade and
awning frame.

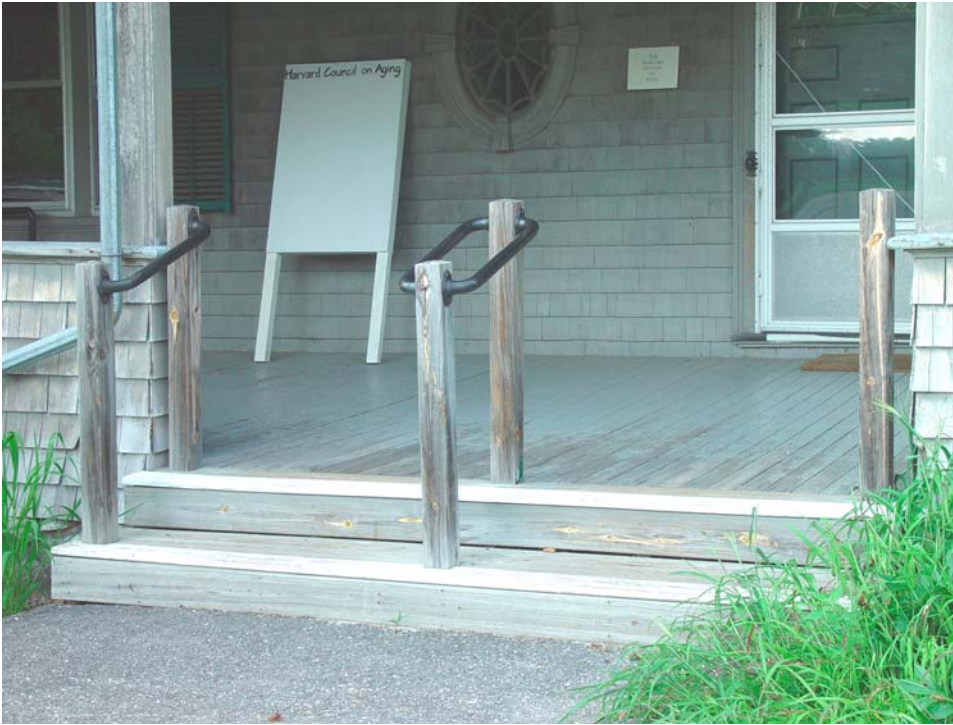
Fig. 70
Main front entry stair, with modern posts and steel grab bar railings.

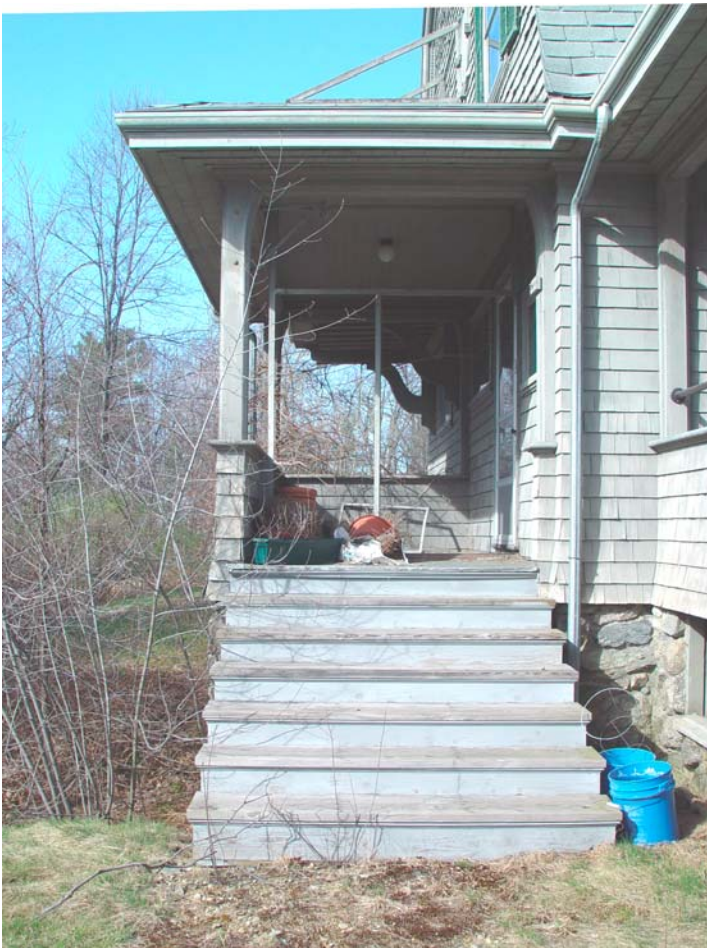
Fig. 71
Recently rebuilt west veranda
stair.

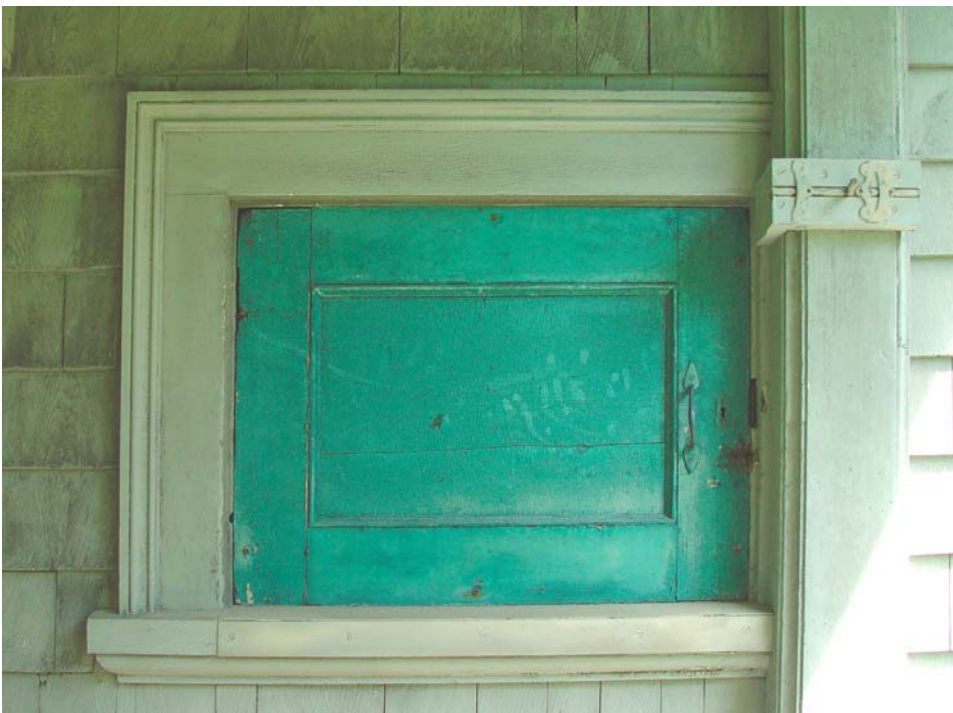
Fig. 79
Obsolete historic hardware on post adjacent to ice box door is benign and
should be left in place.

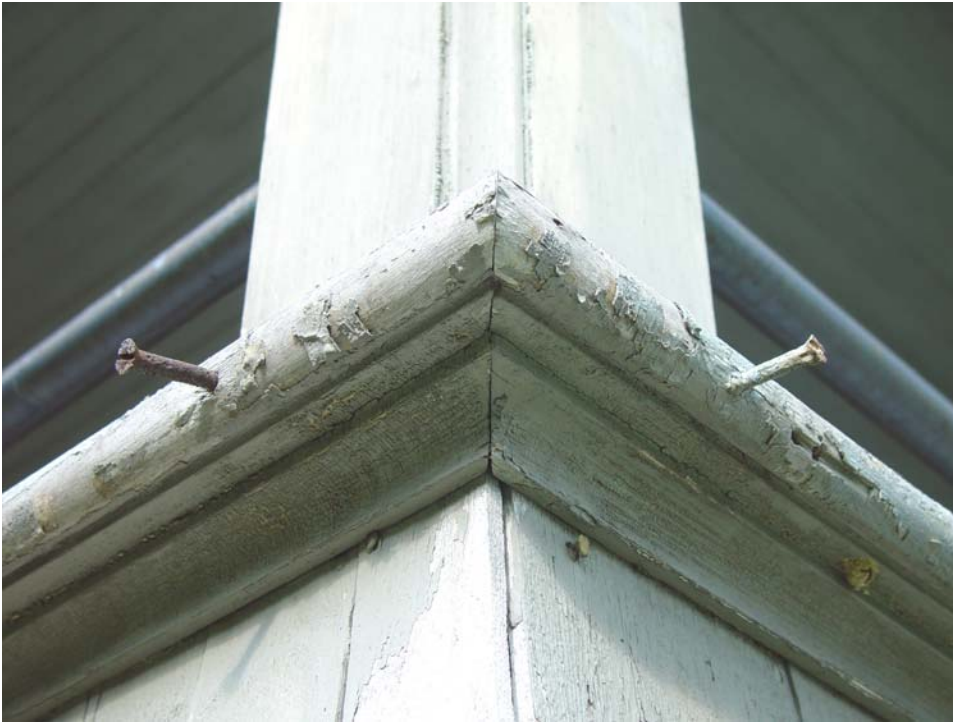
Fig. 80

Abandoned anchors such as these in the edges of parapet caps should be removed only if they are causing deterioration (these are not).

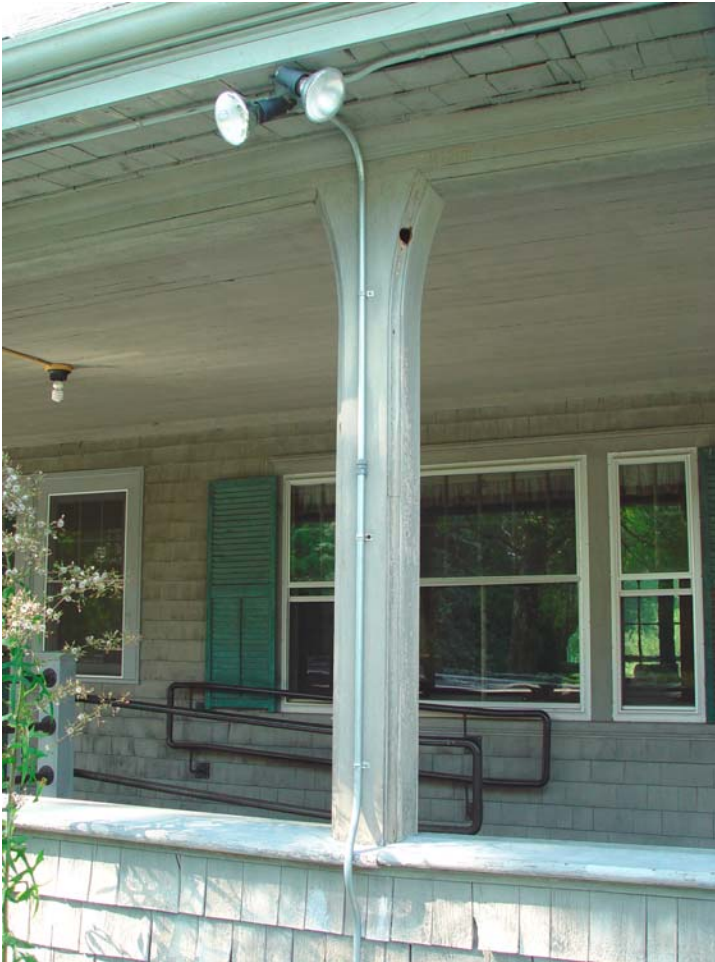
Fig. 82
Surface mounted conduits
and fixture boxes of exterior
floodlight system.

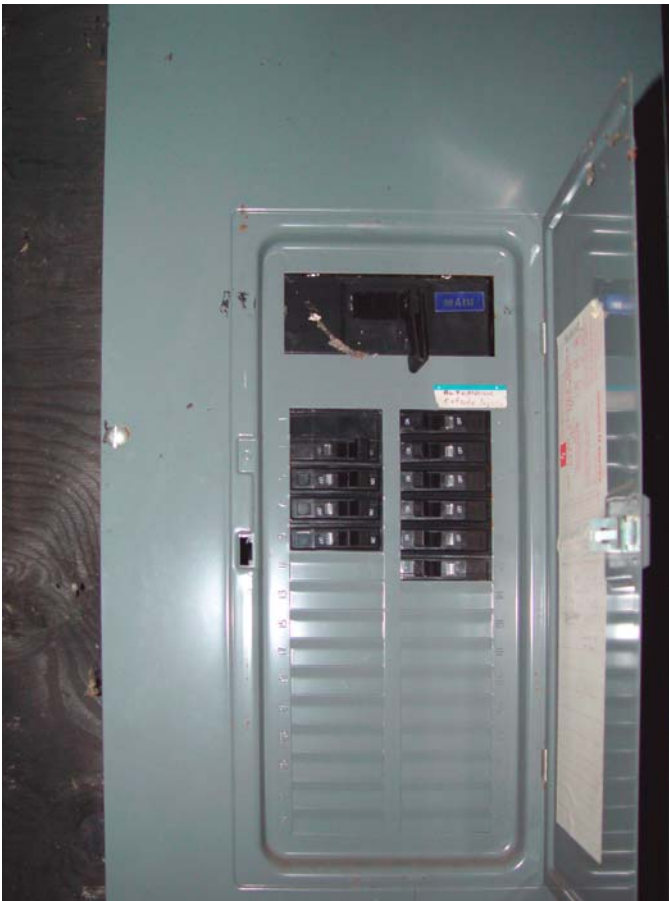
Fig. 85
Electrical main panel on north
wall of cellar.

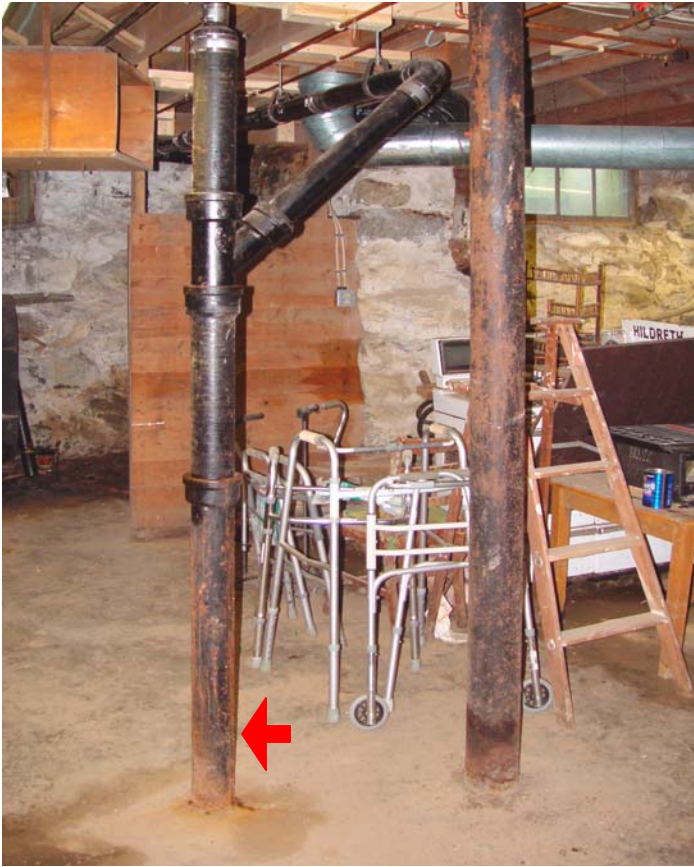
Fig. 88
One of two main sanitary drains
penetrating the concrete cellar
floor.

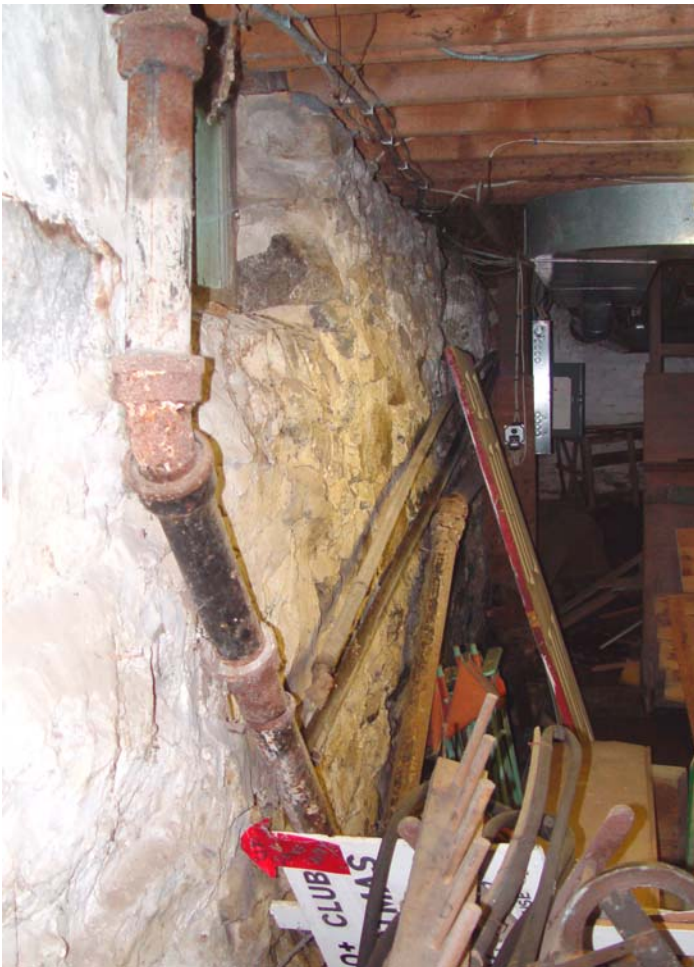
Fig. 89
Conductor drains on north wall
of cellar converge and penetrate
the concrete floor.
